**Interim HVAC Report for the:**

**ORLEANS FIRE DEPARTMENT**

58 Eldredge Park Way  
Orleans, MA 02653

January 31st, 2020

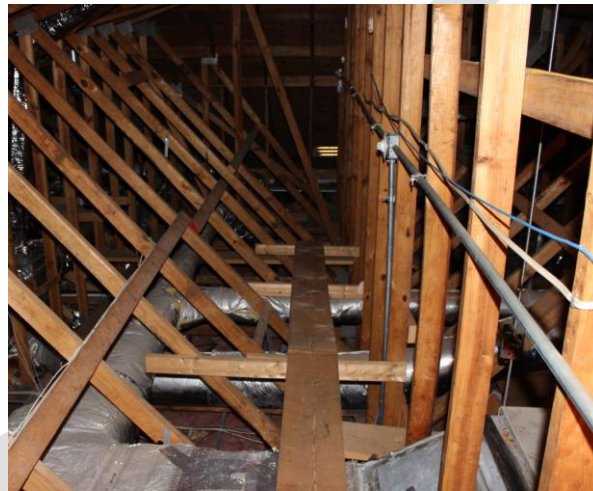
**1.1.2 Maintenance Access:** The AHU's in the attic are located at the far end of the building (Southern end) from where access is provided in the ceiling of the Day room. Access to each of the AHUs are limited as it requires one to traverse 2x10 planks that have been secured to the cross bracing that makes up the wooden truss system of the roof which creates a hazard for maintenance personnel. Servicing these units is difficult and not practical.

*Typical access for attic AHUs*

Dedicated pathway for servicing attic Air Handling equipment, with new service platforms for the new air handling units.

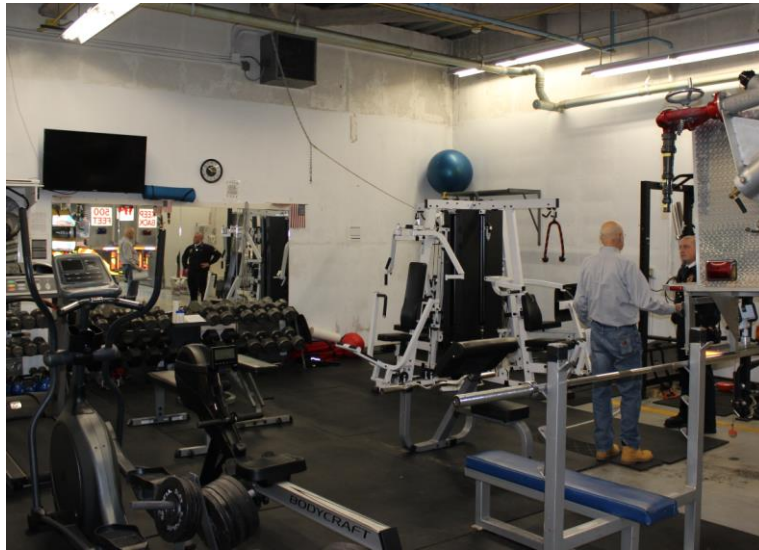
*Fitness equipment located on the apparatus floor*

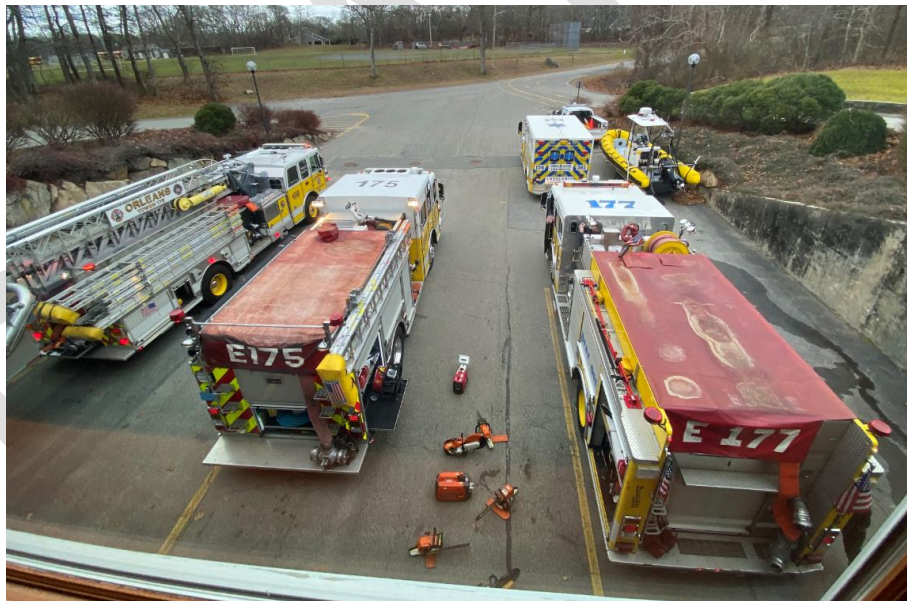
It was noted during Test #3 that when the trucks were started on the apparatus floor and pulled out, it took less than 5 minutes for the entire front half upper level of the fire station to fill with strong odors of exhaust gasses. Source capture plymovent systems were in place and operational at the time, smells only occurred when trucks were pulled outside.

However, A quick and noticeable increase in CO, VOCs, and ultrafine particles occurred within 5-10 minutes of the diesel engines becoming active during Test #3. In addition, a strong diesel odor affected various indoor areas. Locations most affected were the office spaces, day room, reception, Rescue Garage, and Apparatus area. Levels in these areas were found to be well above what would normally be found in a typical office environment. Less impacted were the bunk areas, adjacent bathroom and locker room.

***Test #3 being conducted leading to higher levels of contaminants***

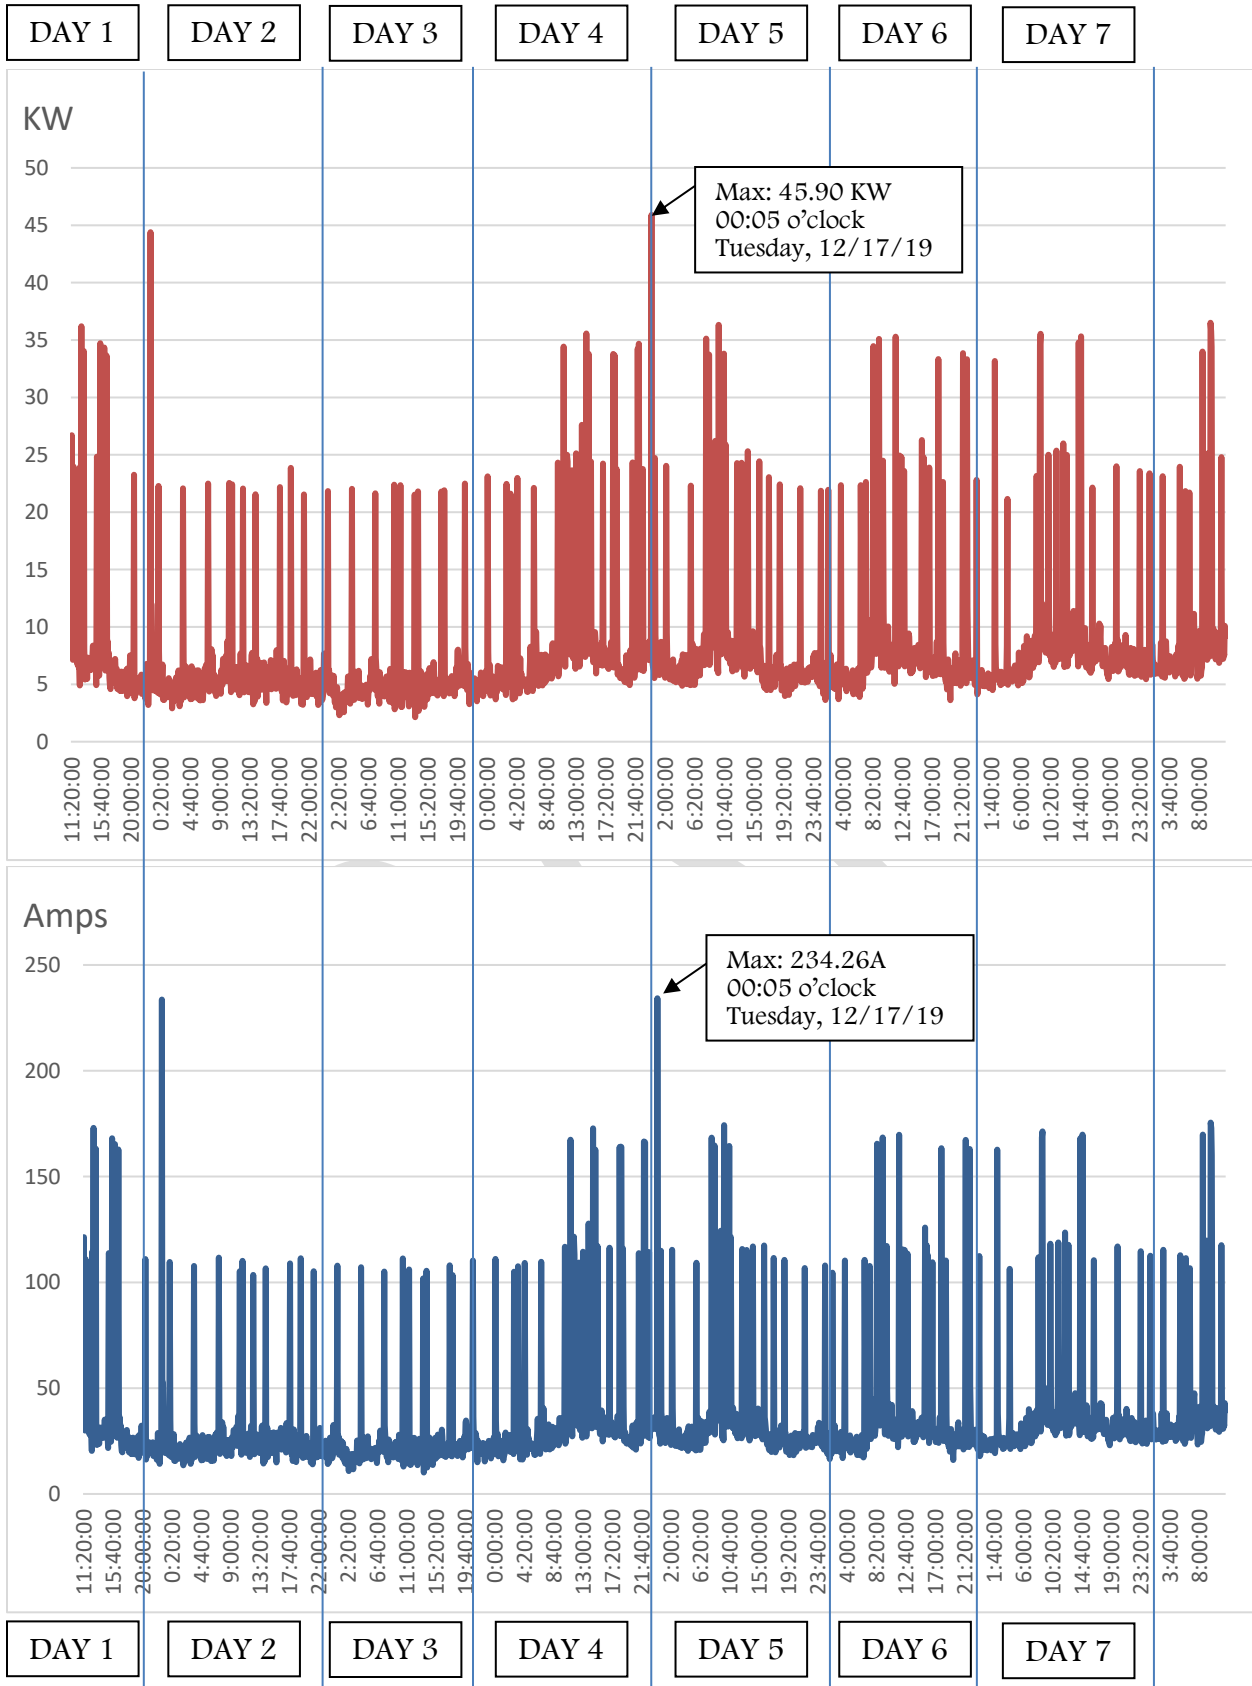
The most relevant data are the amperage (A) and power (KW), which are mapped out on the graphs on the following page. The maximum load on the fire station's service is 45.90 KW, and the corresponding maximum amperage was 234.2A. There is currently a compressor at the Fire Station that was not active during this study since the power meters were installed during December with a full load amperage of 22.8A. MEI assumes that this is counterbalanced by the Electric Unit Heaters that were active during the study but will not be active during the summer.

MEI concluded that while the existing 400A 120/240V service does have a moderate amount of capacity for growth, the existing service should be replaced, even if in kind, to resolve the issues noted in the analysis of the existing conditions above.
