TOWN OF ORLEANS

FIRE STATION FEASIBILITY STUDY

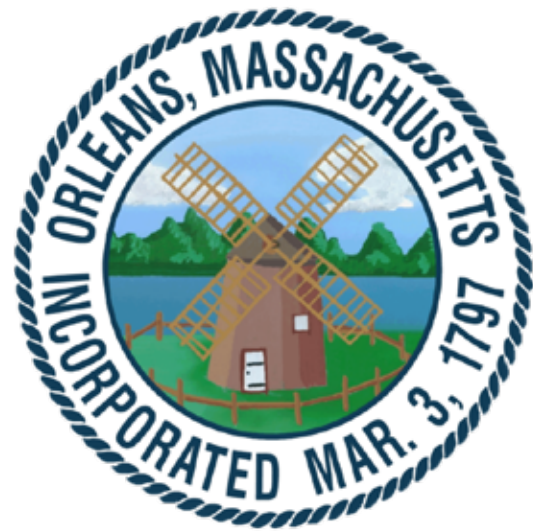
FIRE STATION FEASIBILITY STUDY

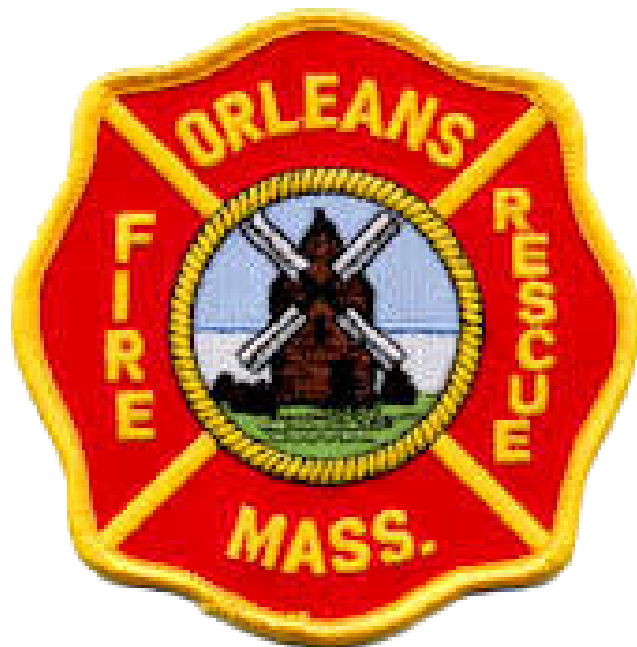
The Orleans Fire Department aims high with their mission statement, vision statement, and core values. This is the first in depth analysis of this site and facility and defines our recommendations for the Town of Orleans.

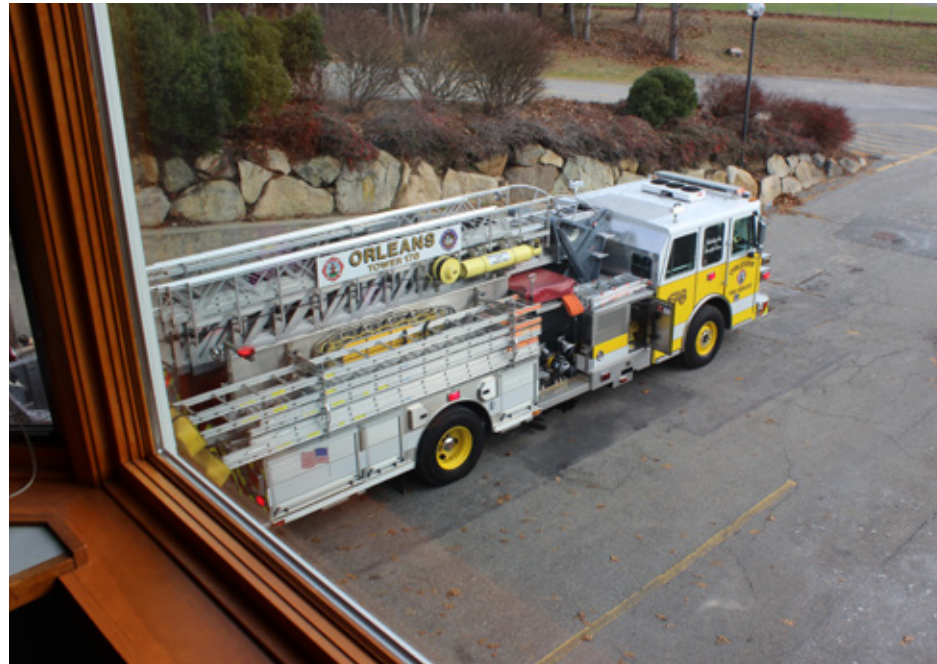
The “tri-level” nature of the building imposes a constant obstacle of traversing stairs to initiate almost every first responder task

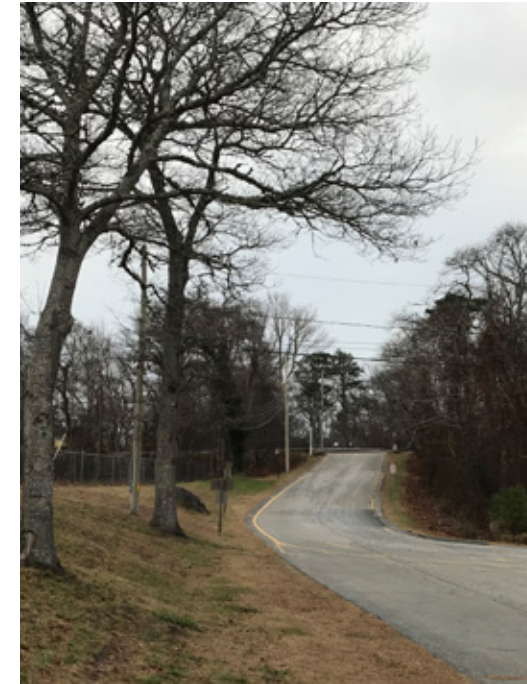
It is highly recommended to locate public safety facilities on relatively flat sites, as close to the street as possible.

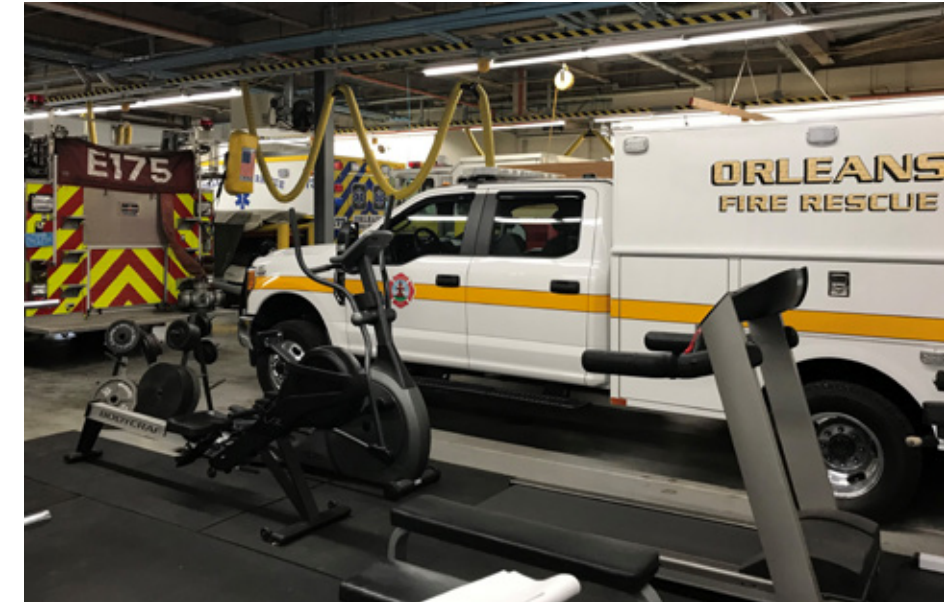
In Orleans, the fitness equipment is located directly on the apparatus floor – the biggest Hot Zone in a fire station – and the worst possible place for deep breathing caused by exercise. Anyone working out on an apparatus floor is breathing in the history of soot, but also potentially any current day carcinogens that return with the trucks and / or the diesel exhaust the trucks emit as they enter the building – even with the Plymovent system. This is a very big hazard and needs to be corrected.

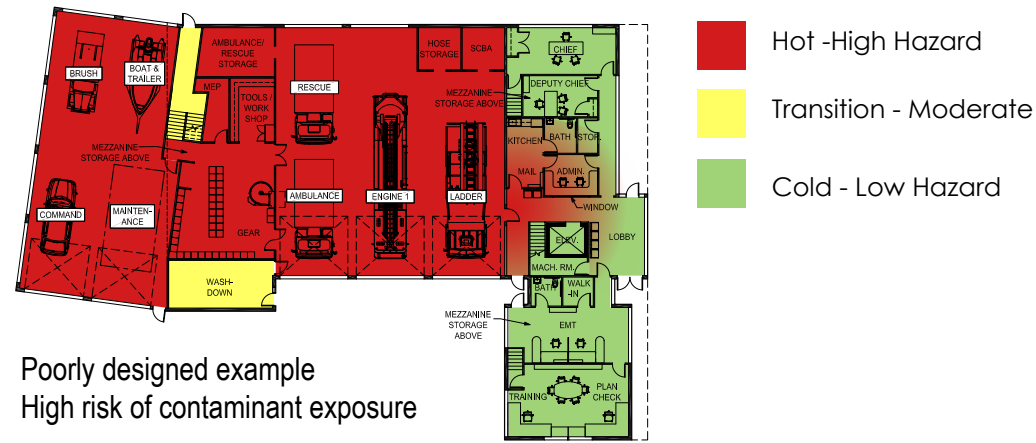
Poorly designed example
 High risk of contaminant exposure

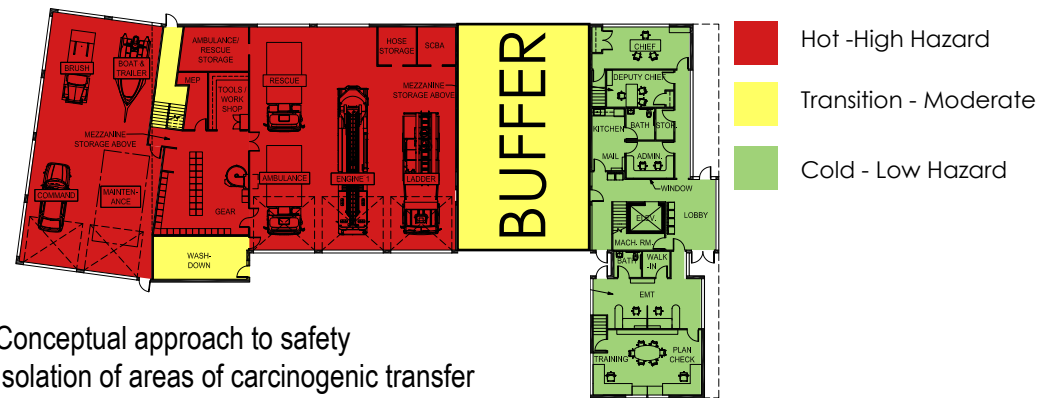
Conceptual approach to safety
 Isolation of areas of carcinogenic transfer
 *Diagrammatic only, not representative of actual size

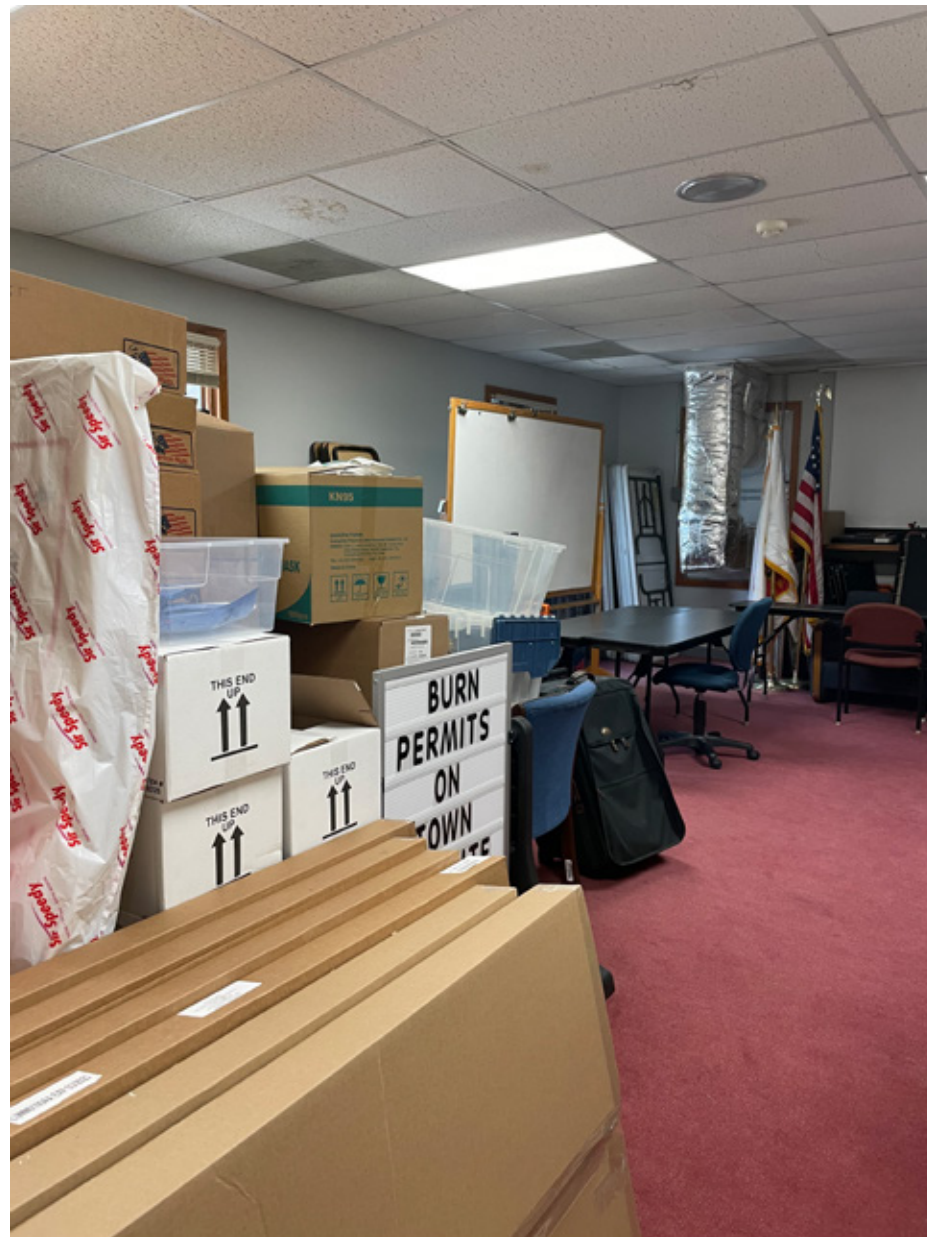
The kitchen is far too small for current staff needs. It does not have emergency shutdown switches needed for when the department is cooking but then needs to rush out to a fire. Systems like these provide safe places for fire fighters to live and work. The kitchen is NOT accessible to those in wheelchairs or others with physical impairments and without a regulatory variance in place, it needs to be. All elements of the kitchen are outdated, inadequate, with limited functionality. It is very clear they lack storage for all that is required in a modern day fire station.

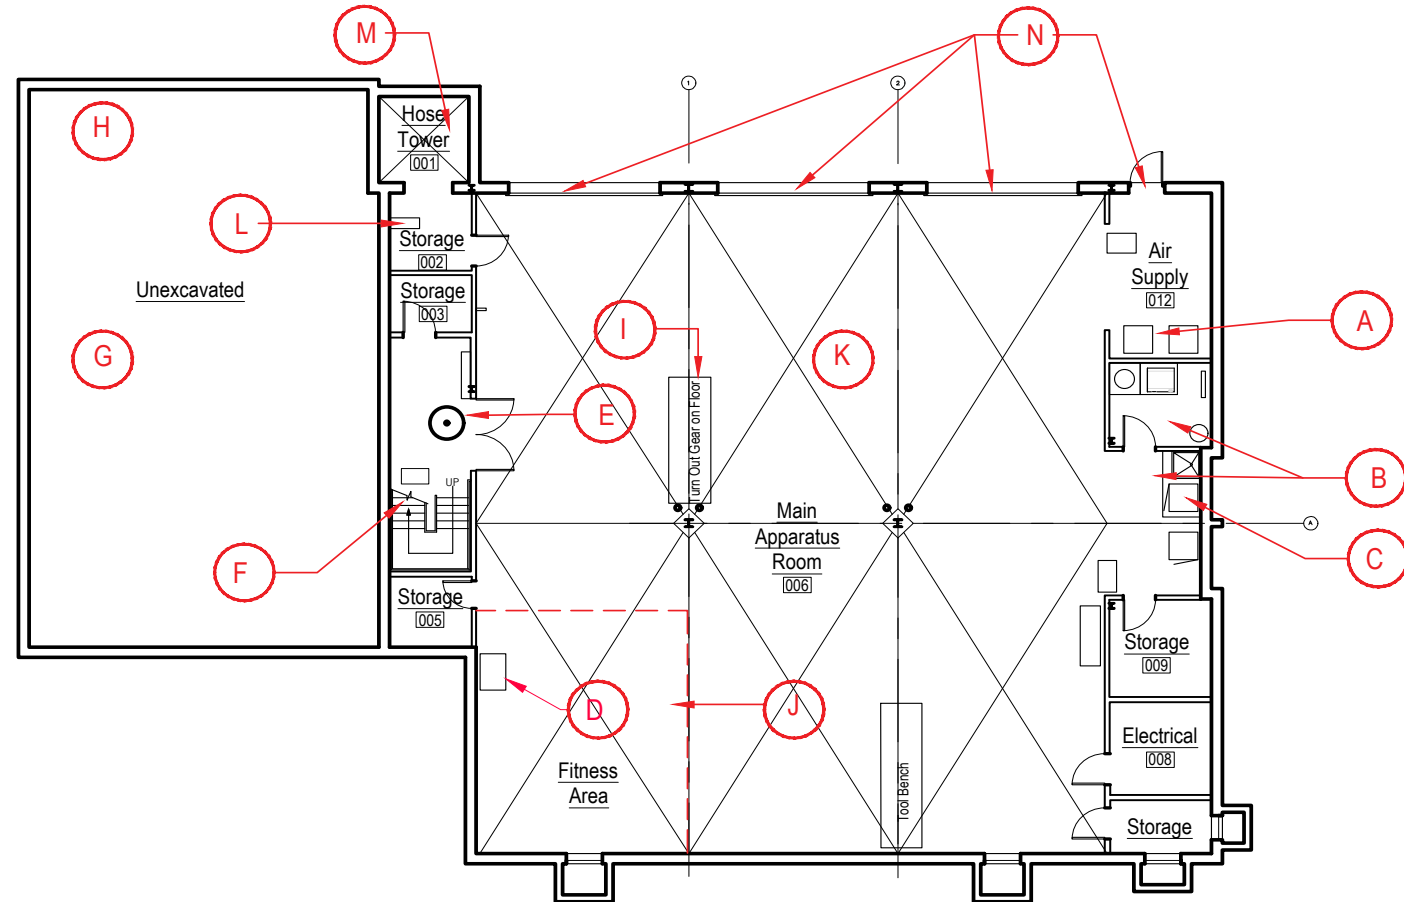
- Lower floor Apparatus door height/Ceiling height - Inadequate for apparatus. Door height at lowest point is currently 11'6", contemporary standards require 14'-0" doors
- Very limited storage
- Electrical service will be insufficient for new service requirements
- Flooding and equipment loss on basement level - potential mold on walls where supplies are stored

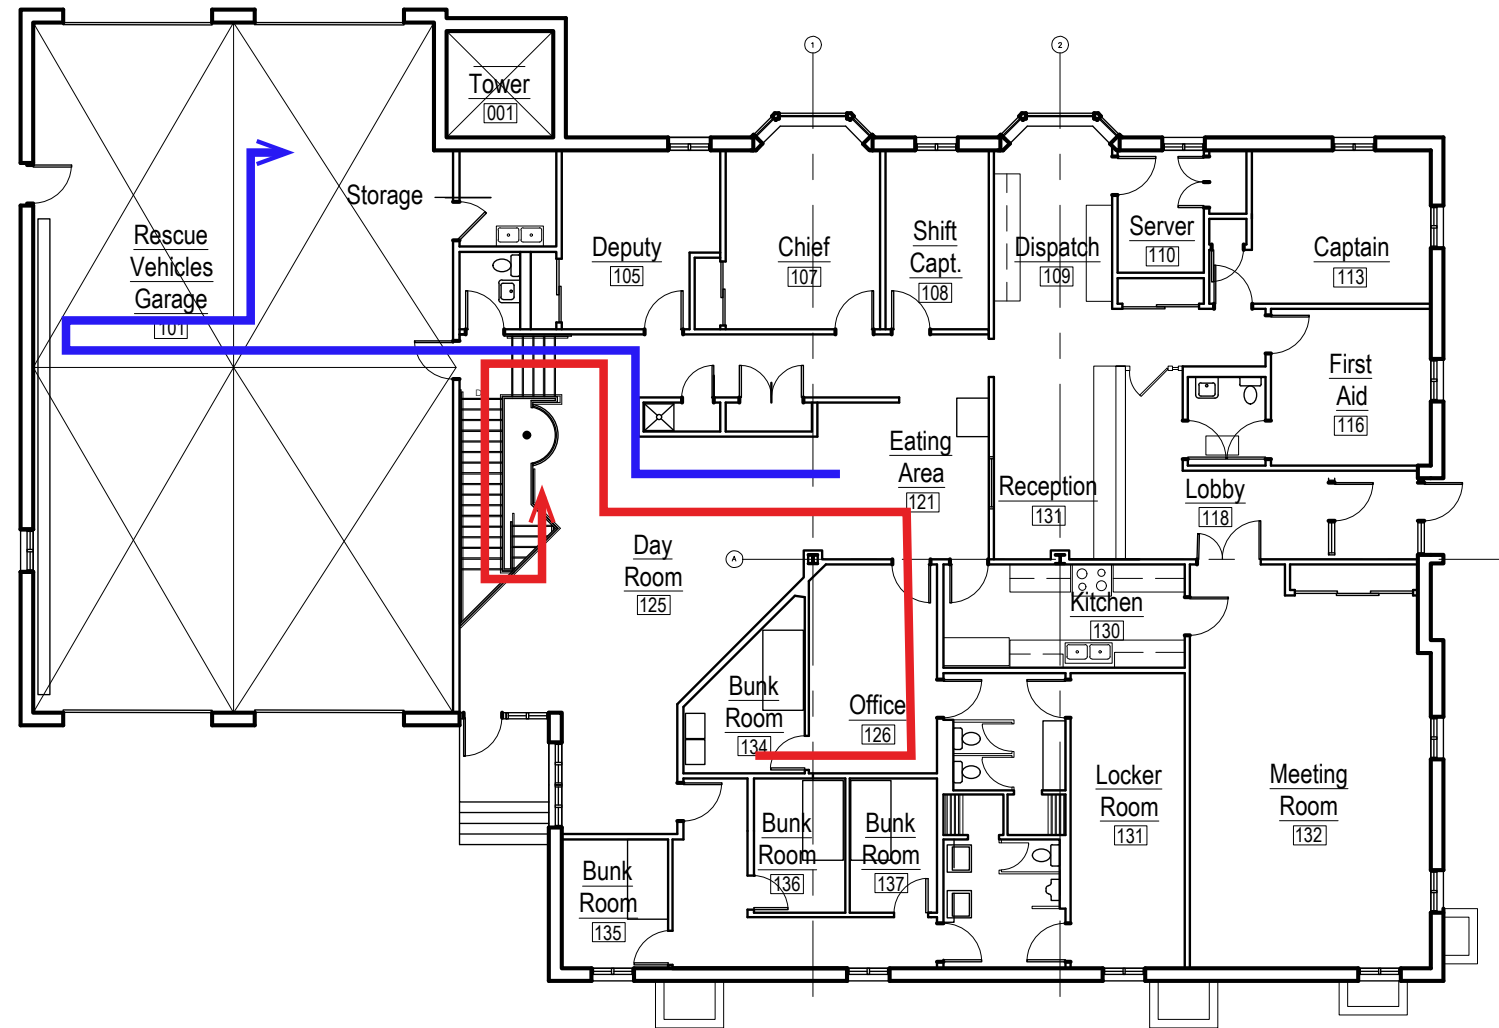
Slow response times due to poor layout

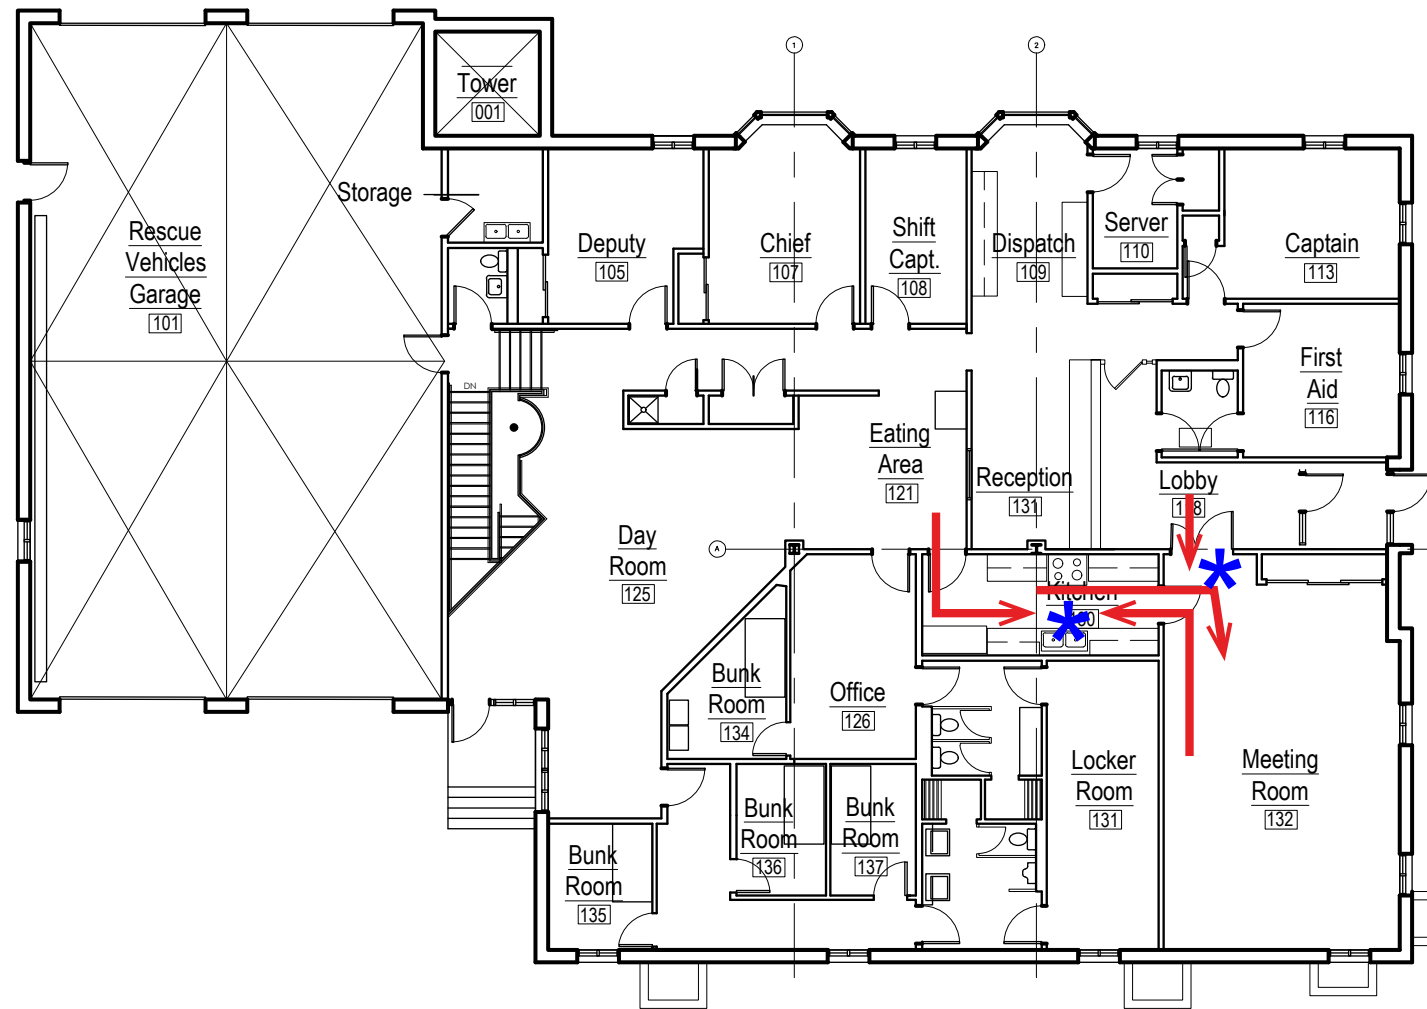
Kitchen - Path in/through kitchen is problematic

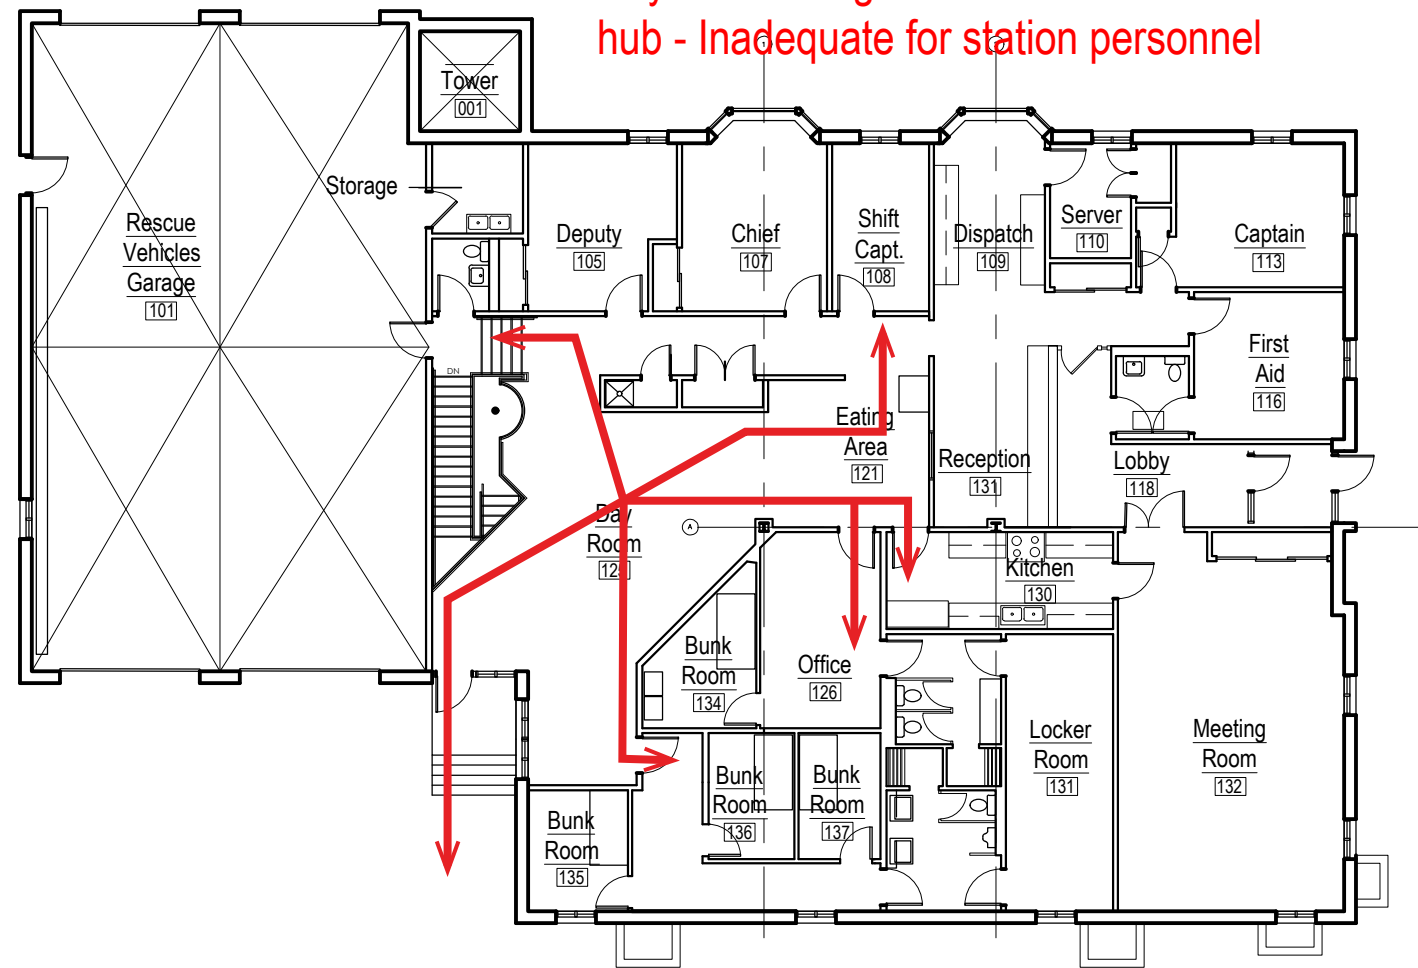
Dayroom/eating area is the main circulation hub - Inadequate for station personnel

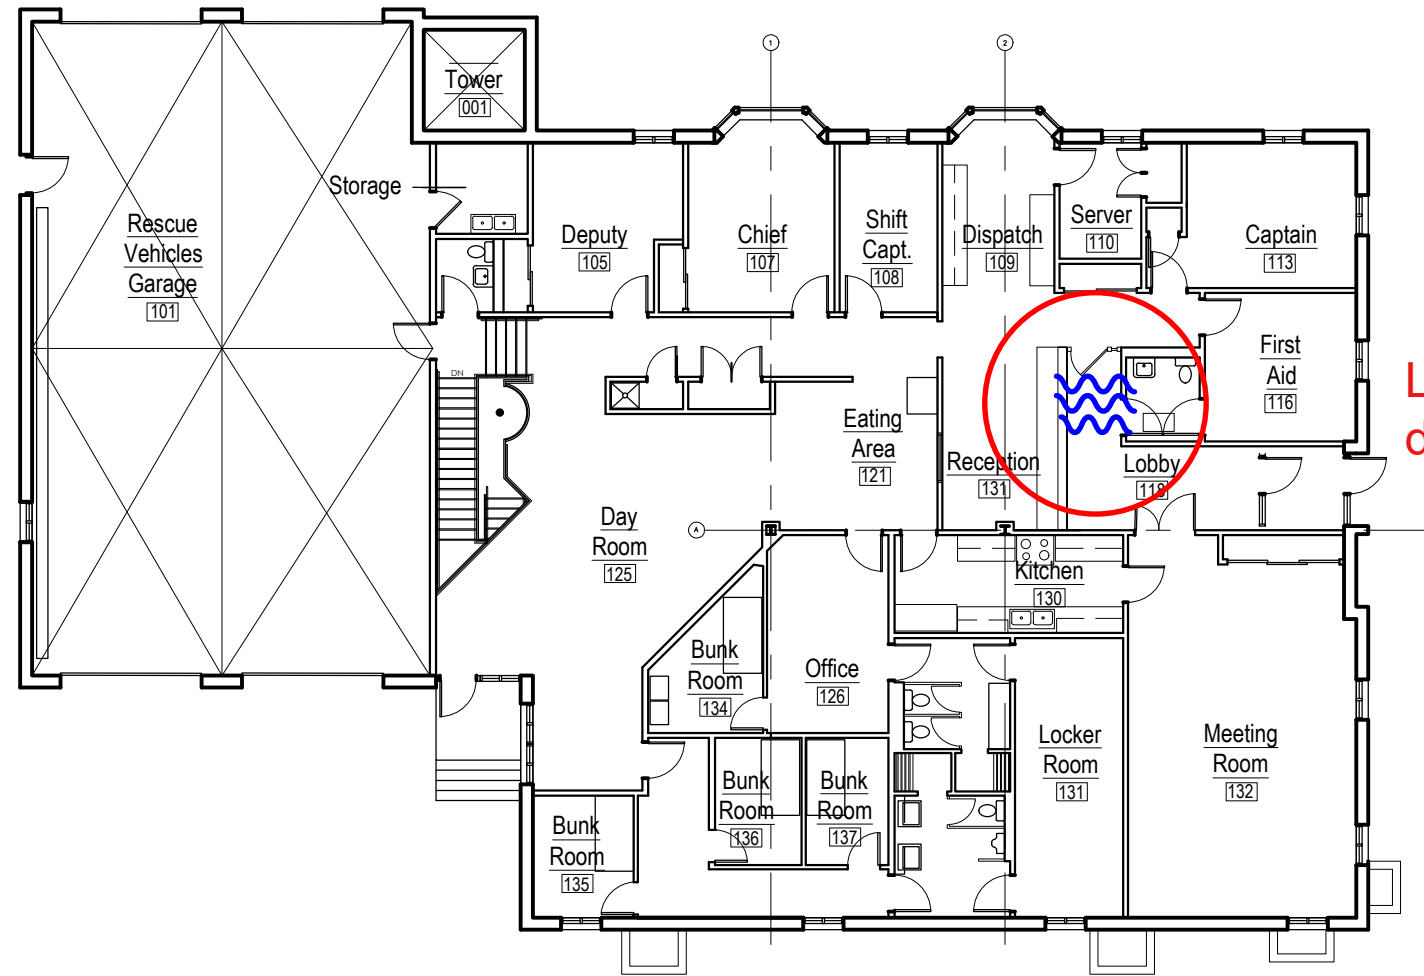
Location of restroom -
distracting/odors

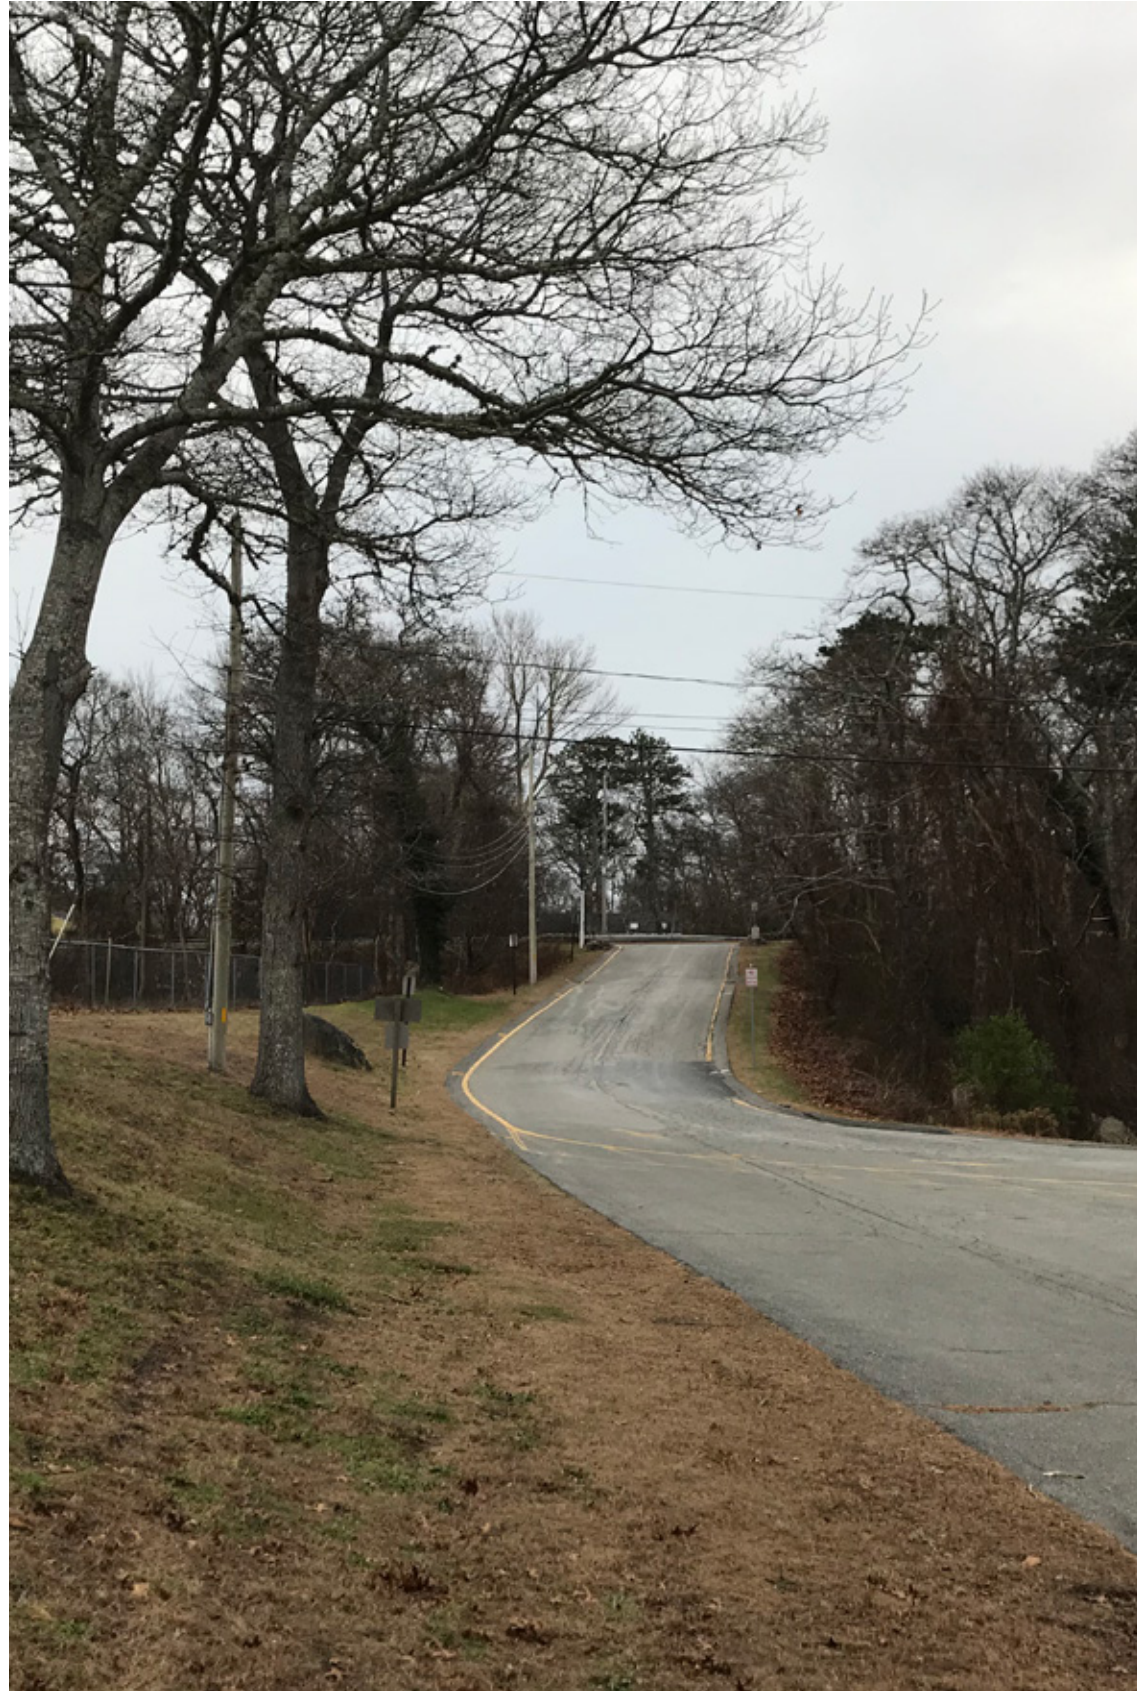
Significant grade changes causing slow turnout time in winter storms

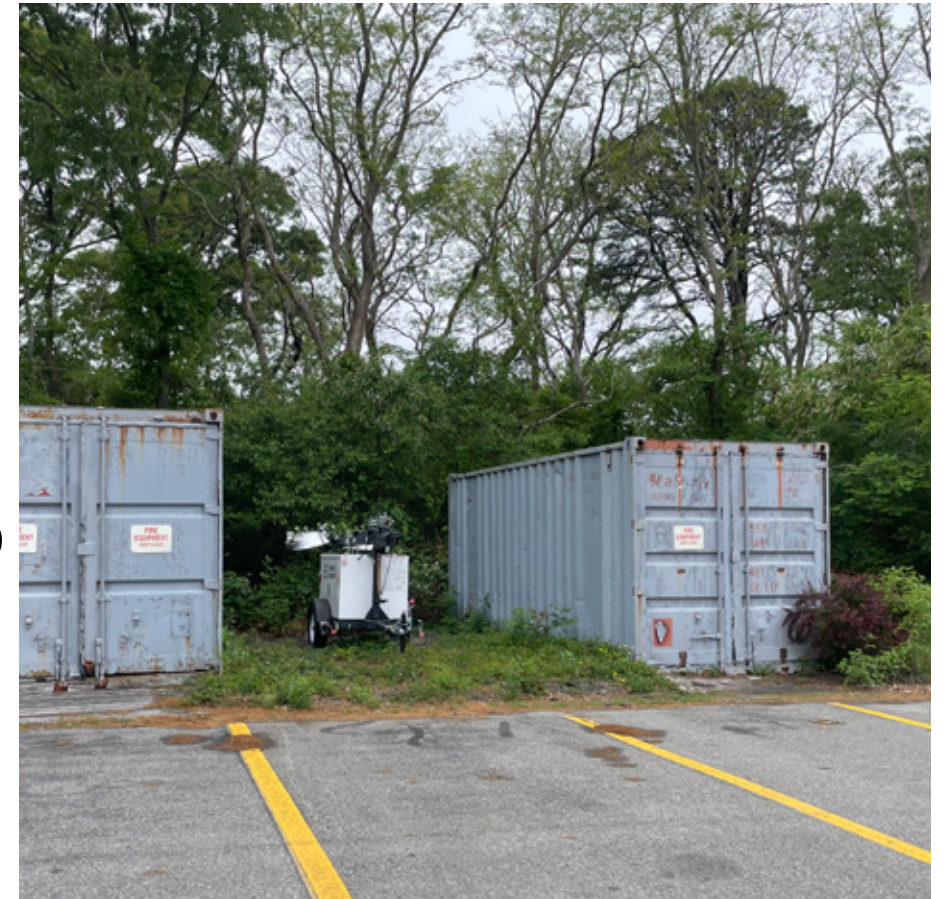
Interim HVAC improvements located to minimize sound issues and structure modifications

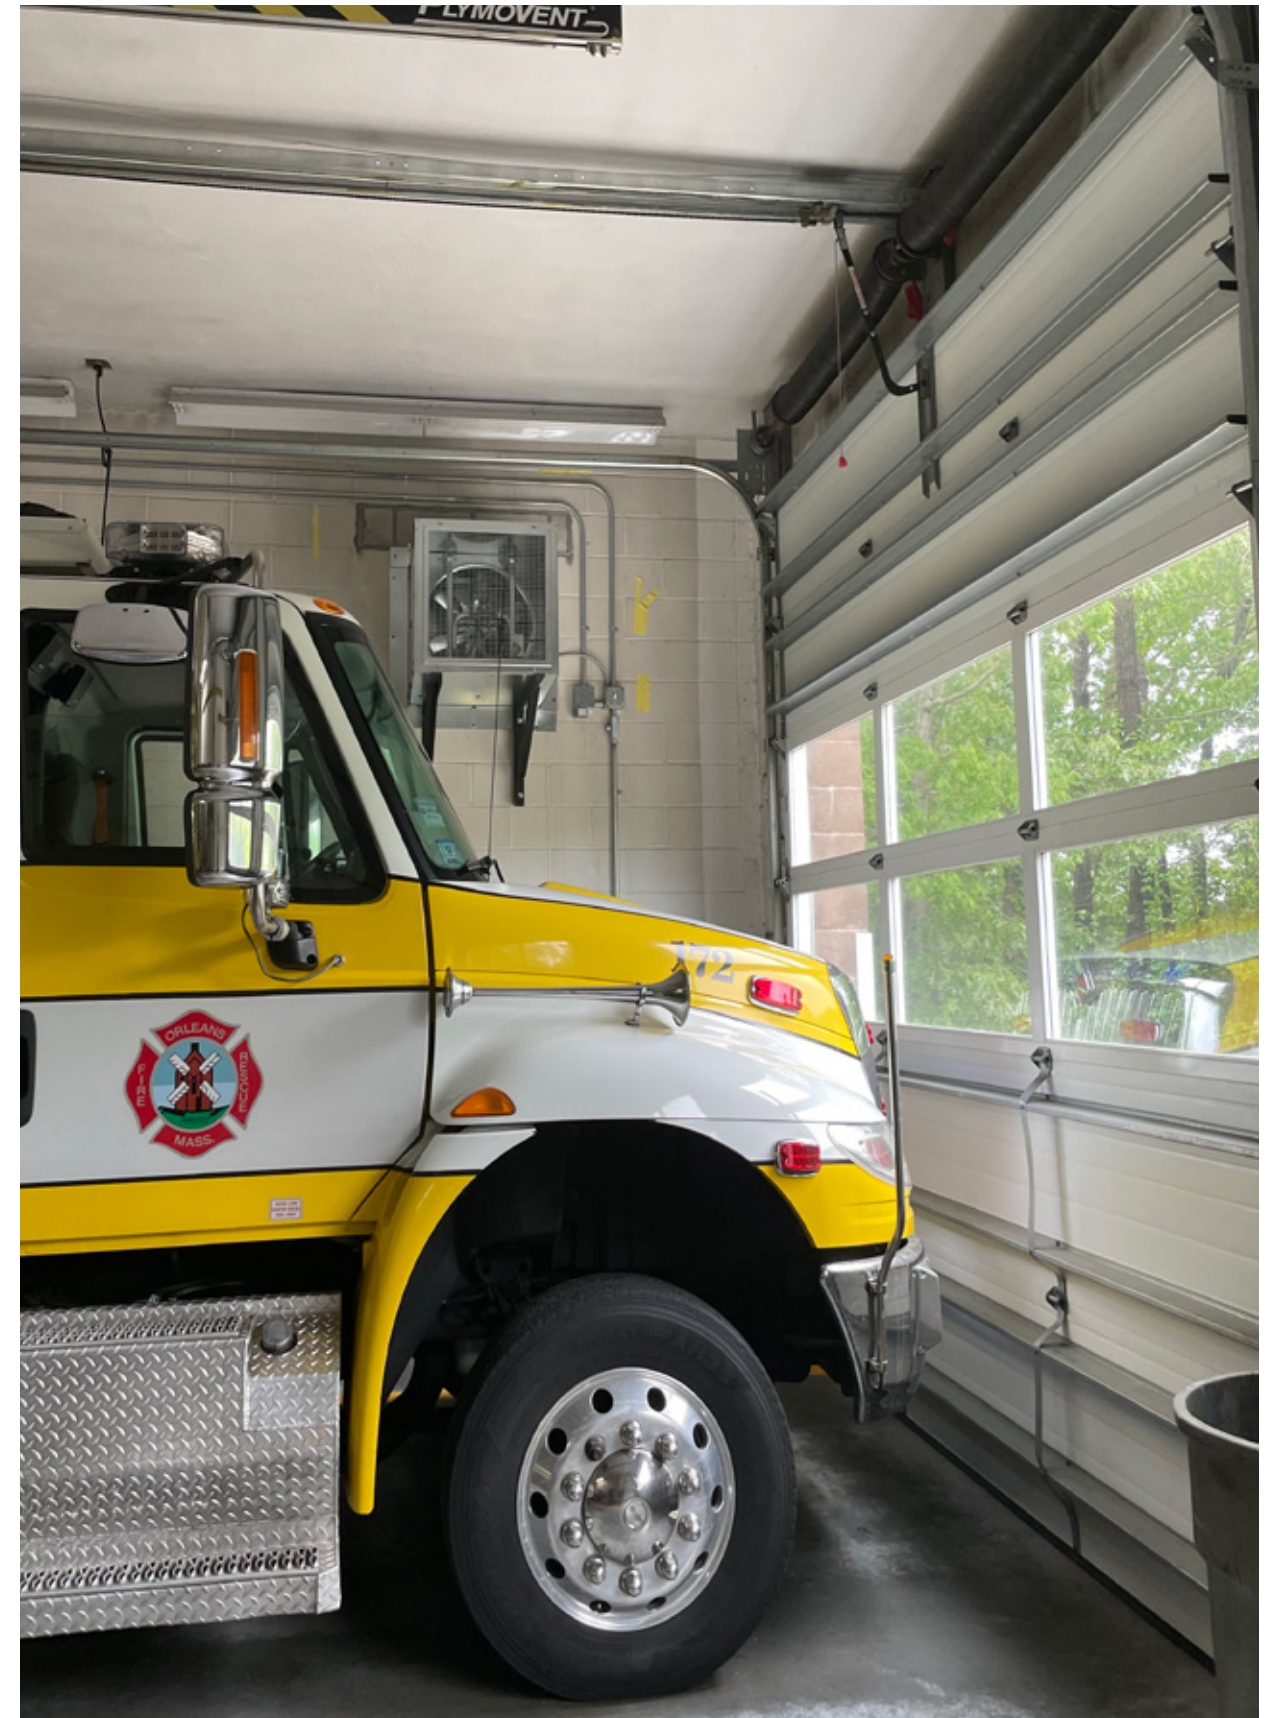
Turnout gear is stored in unsafe conditions in the apparatus bays and does not conform to NFPA standards

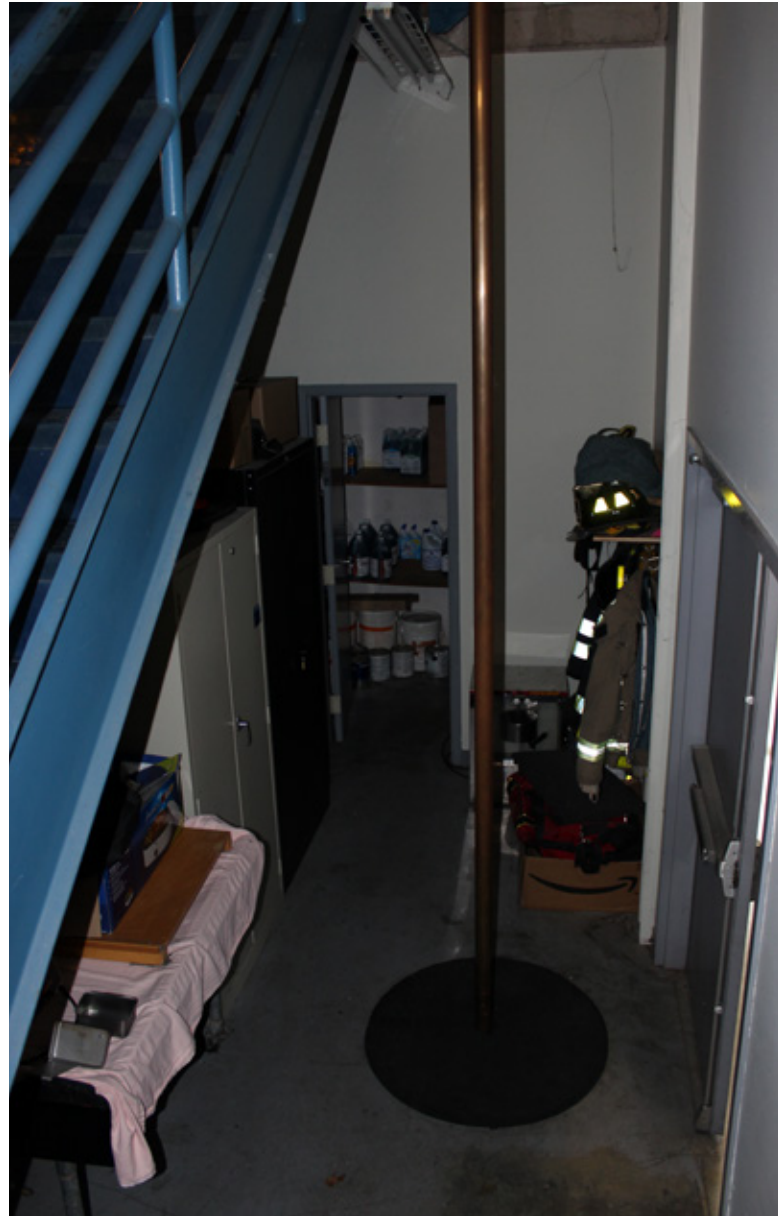
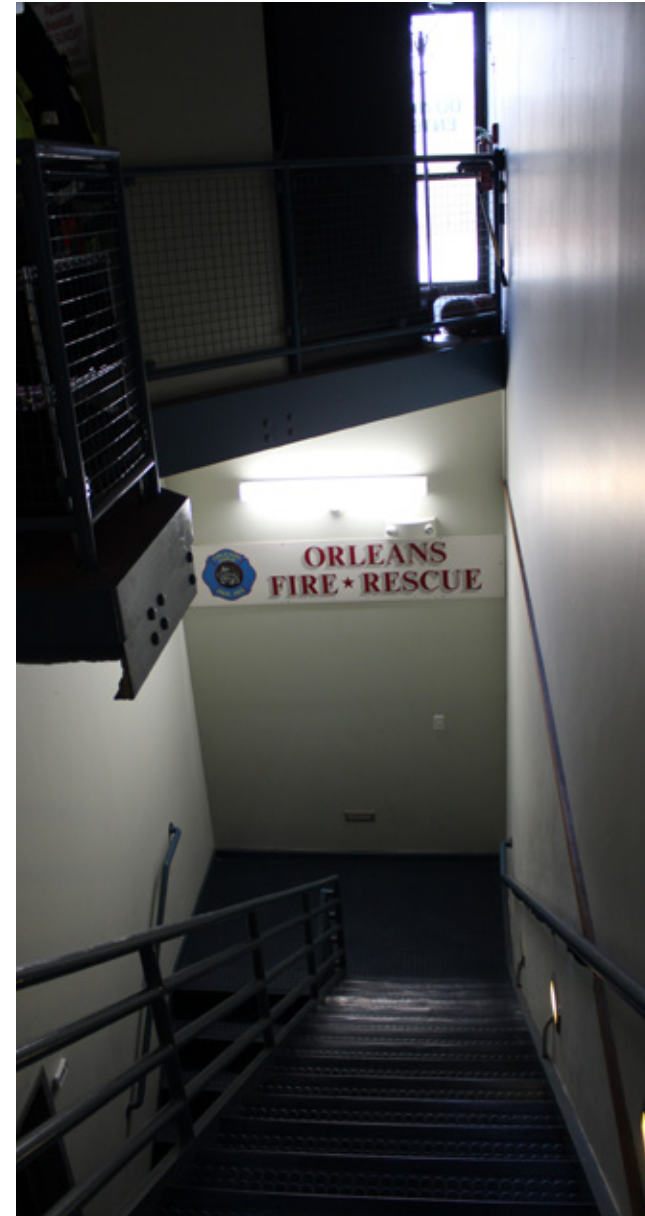
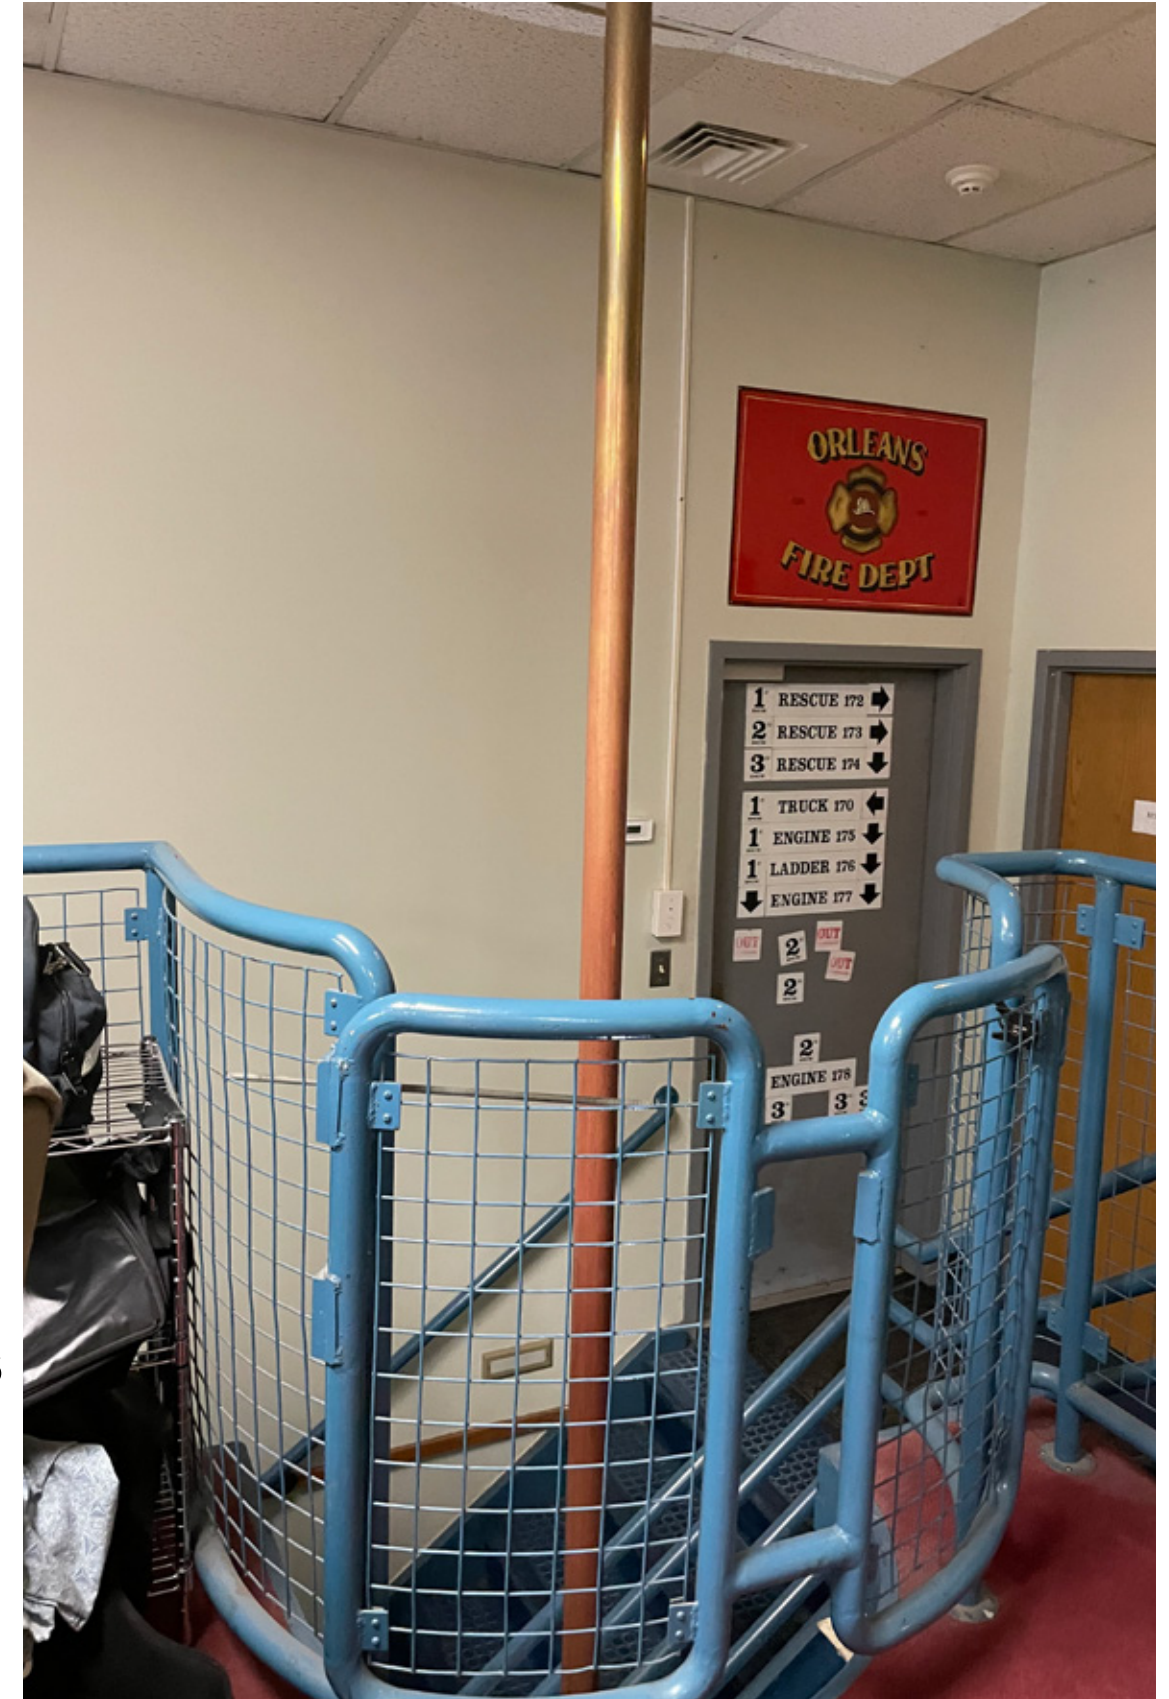
- No air separation between the apparatus bay and the living quarters
- Pole does not meet safety guidelines
- Pole is not used and is a space waster

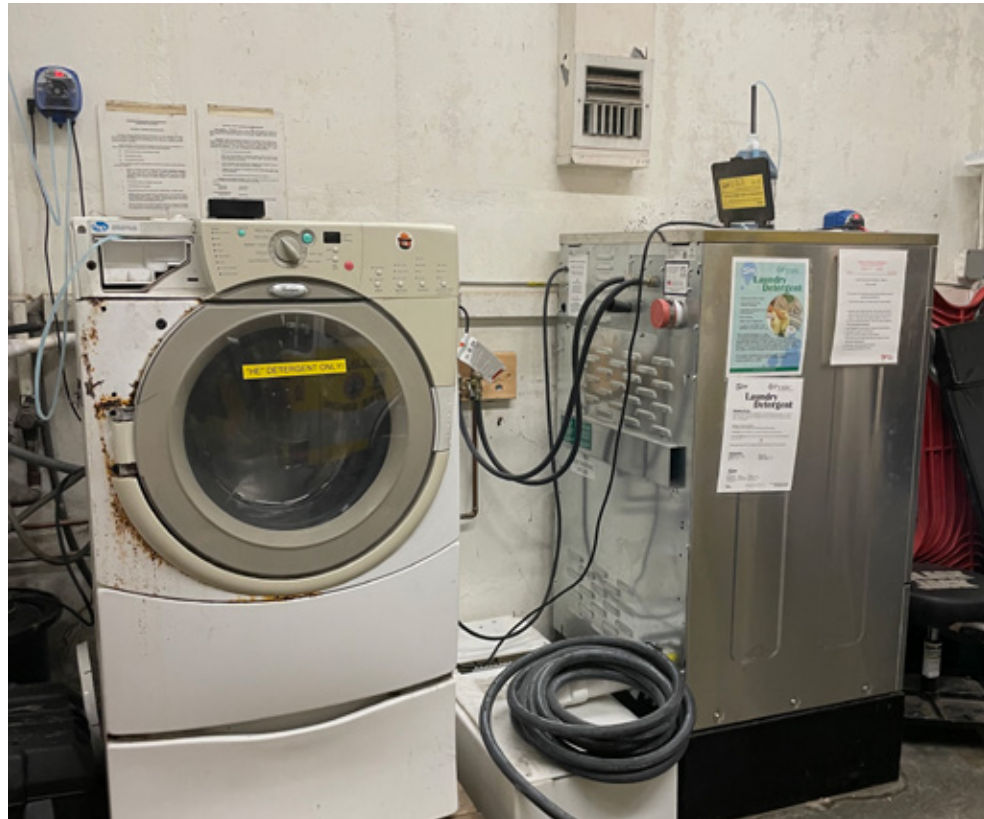
Lower Apparatus Bay Issues
