TOWN OF ORLEANS

FIRE STATION FEASIBILITY STUDY

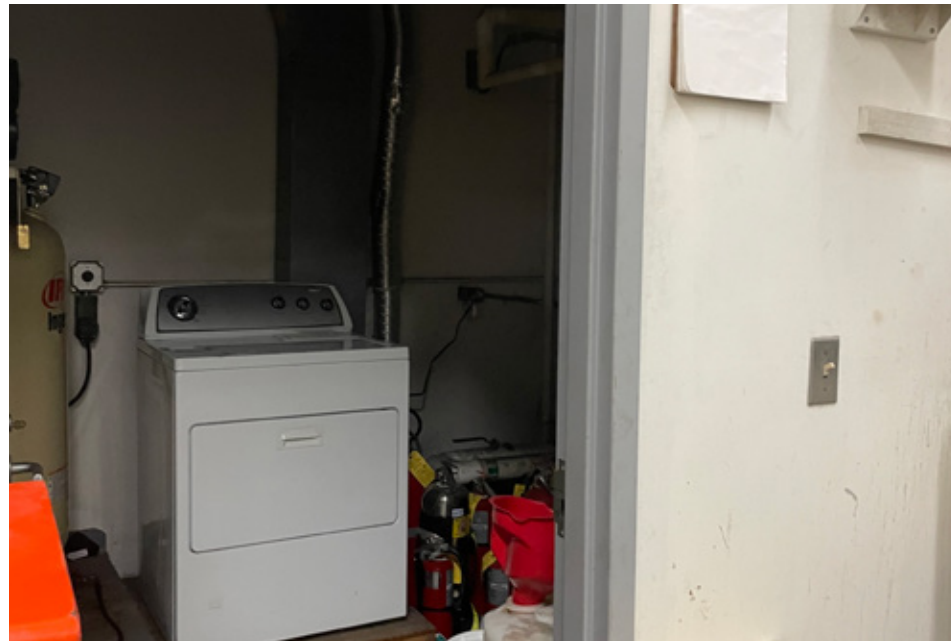
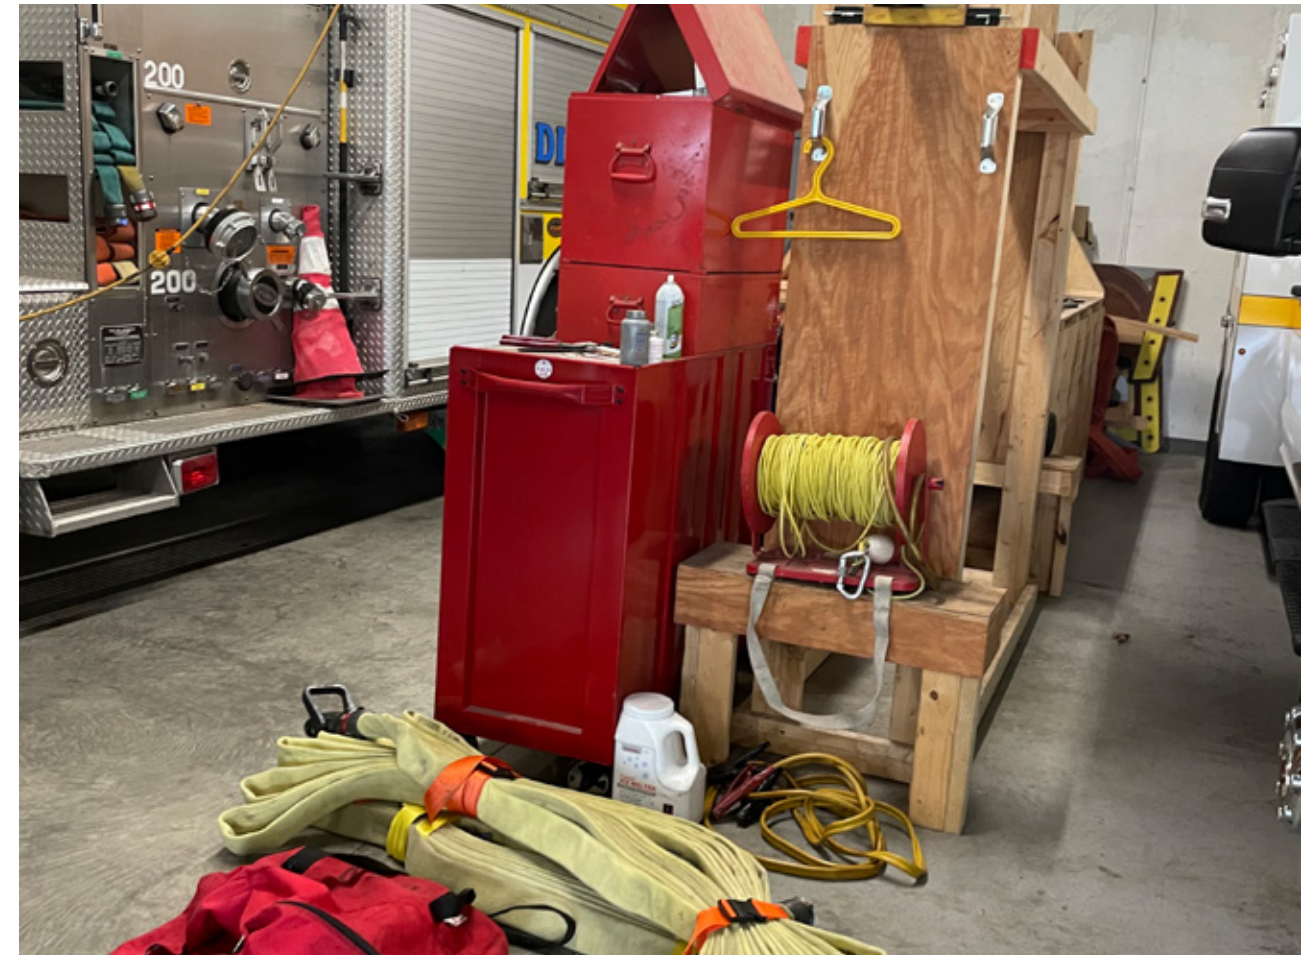
- Inadequate and not isolated laundry facilities
- Inadequate repair space
- No proper ventilation
- Inadequate plumbing services

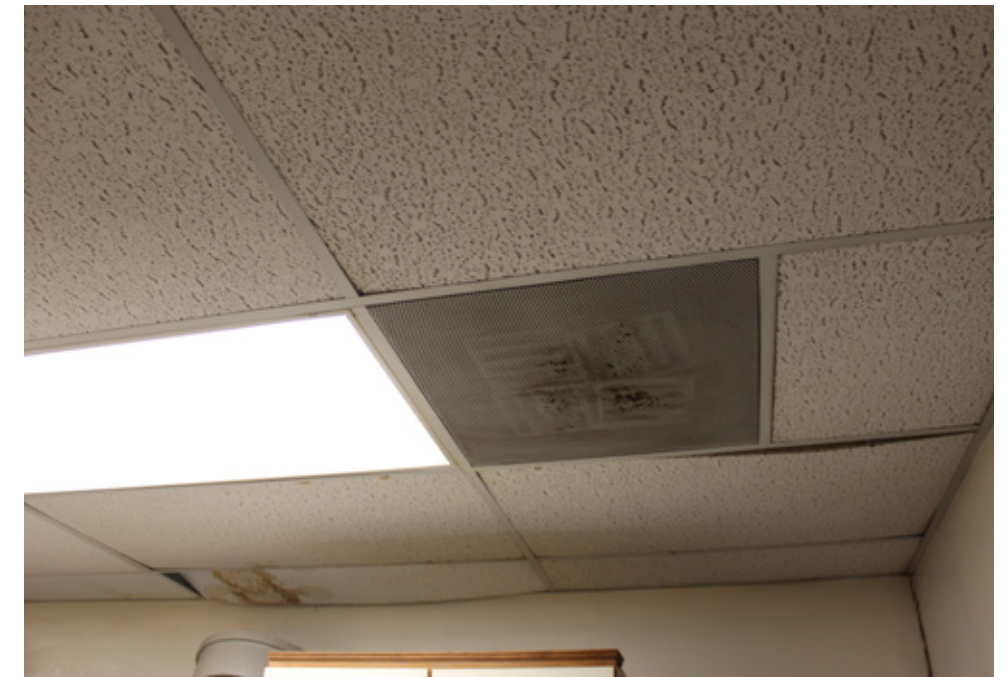
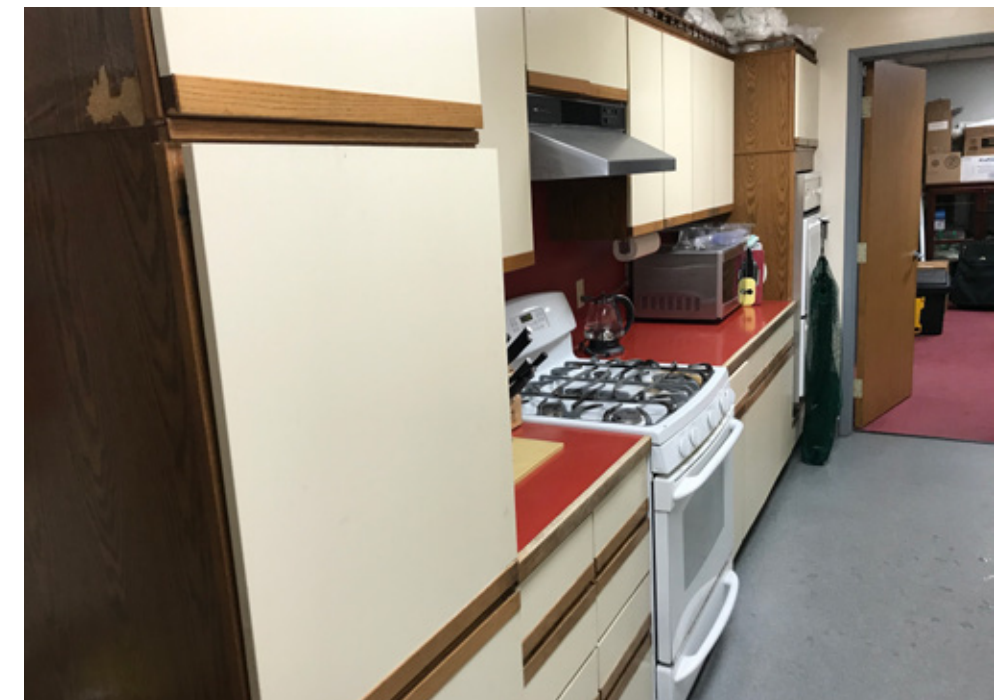
- Inadequate Facilities
- Outdated and outgrown
- Not MAAB Compliant

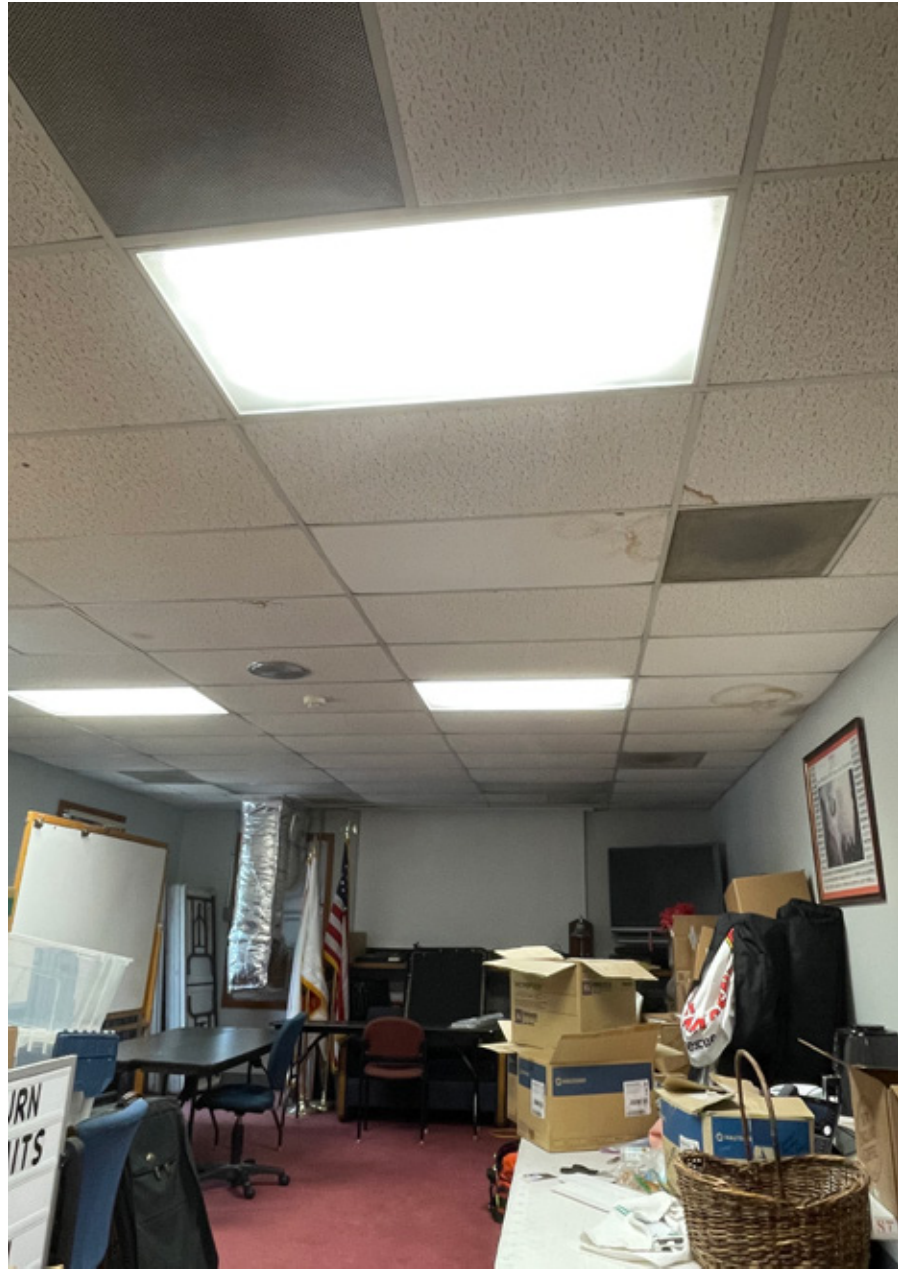
Training/Meeting Room currently serves primarily as storage. Space needed for station meetings/back up Emergency Operations Center

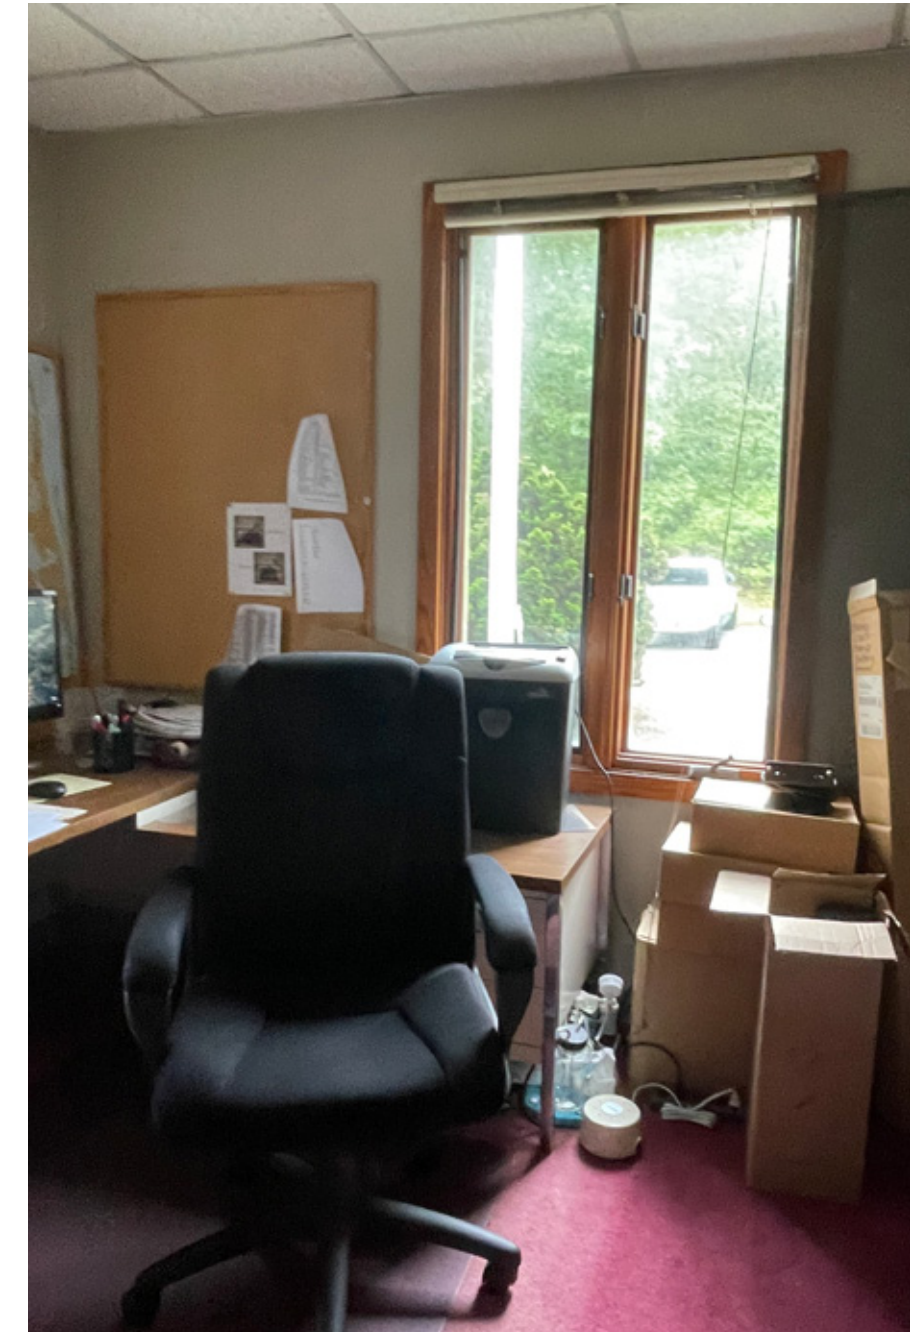
Office space crowded with stored equipment and supplies

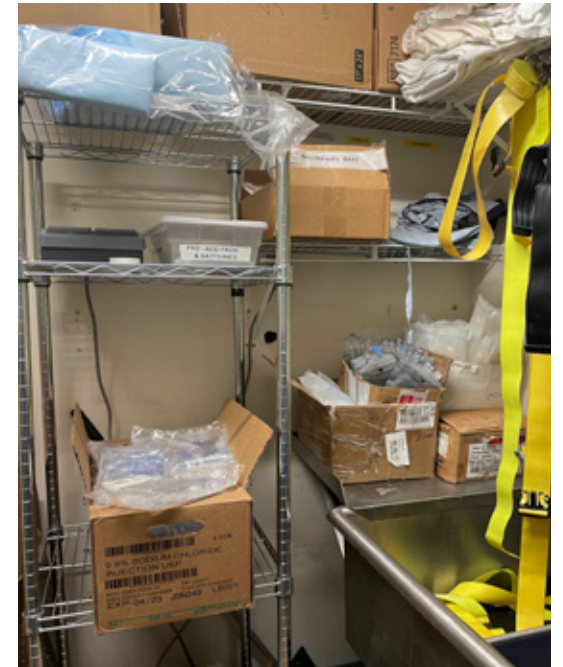
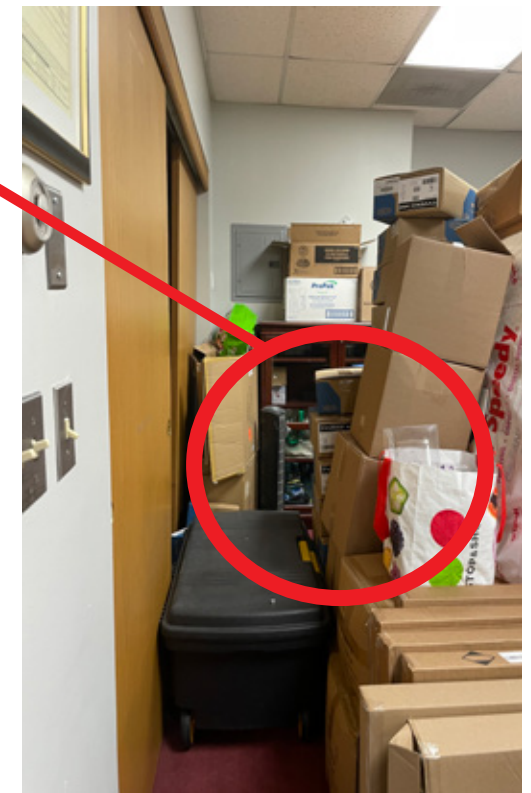
Storage found throughout the building in non-designated areas including in the dayroom, under stairs, and on top of cupboards

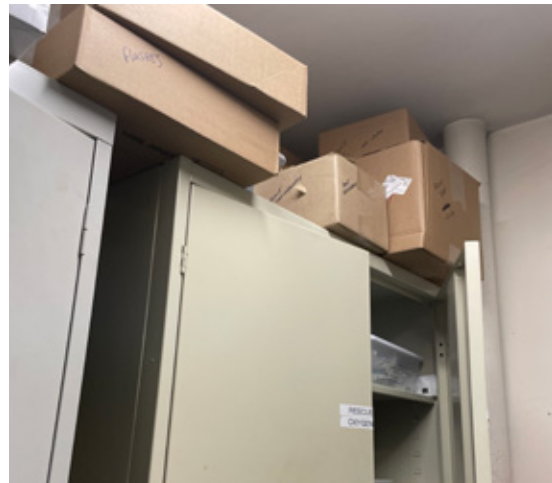
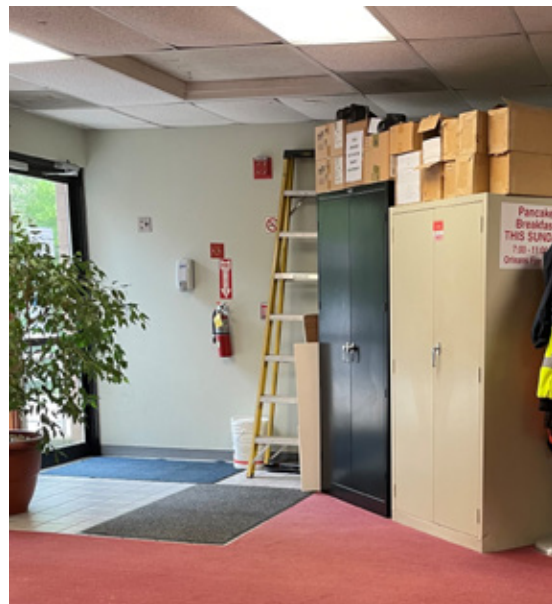
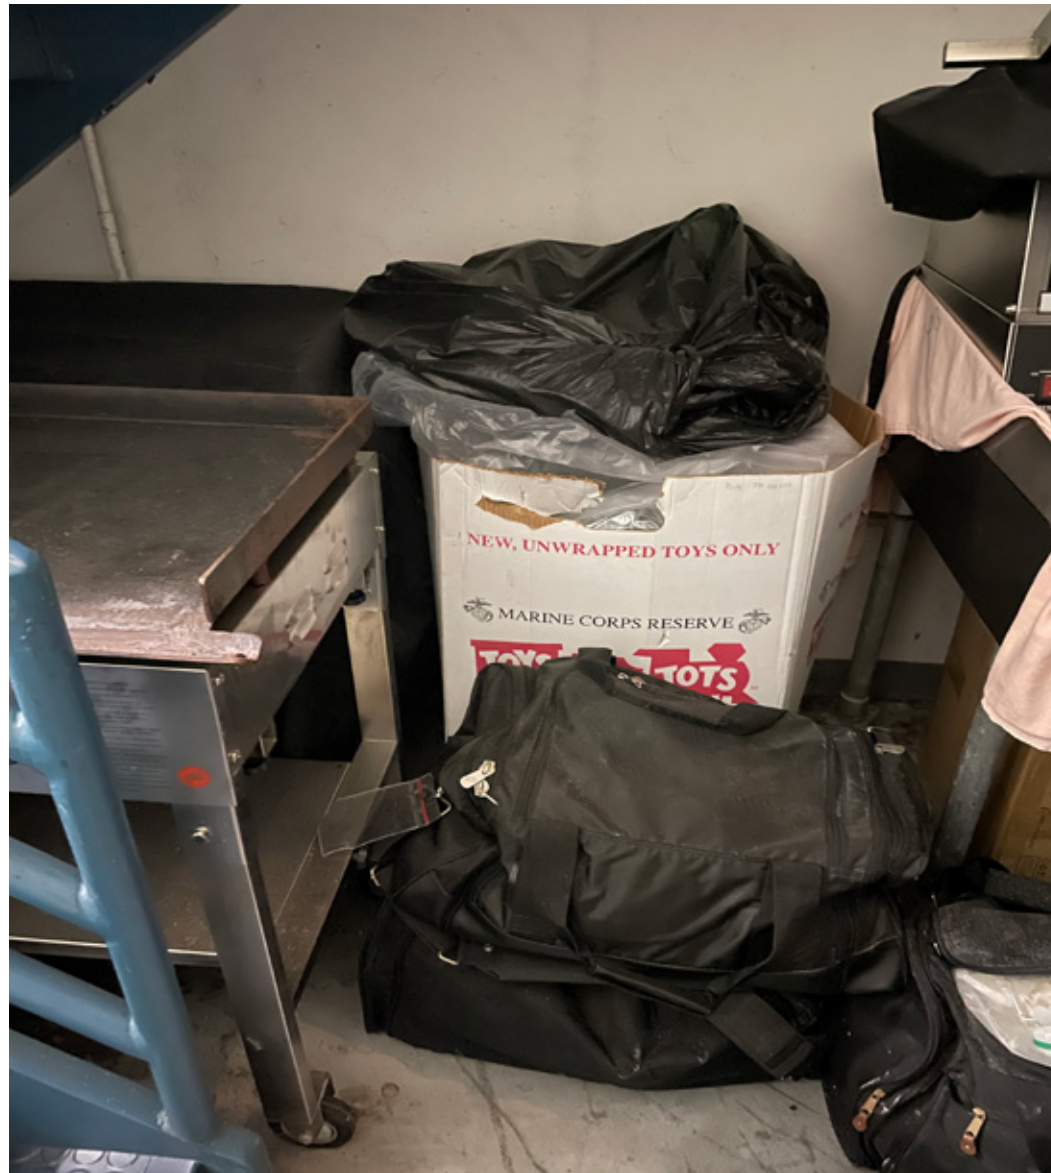
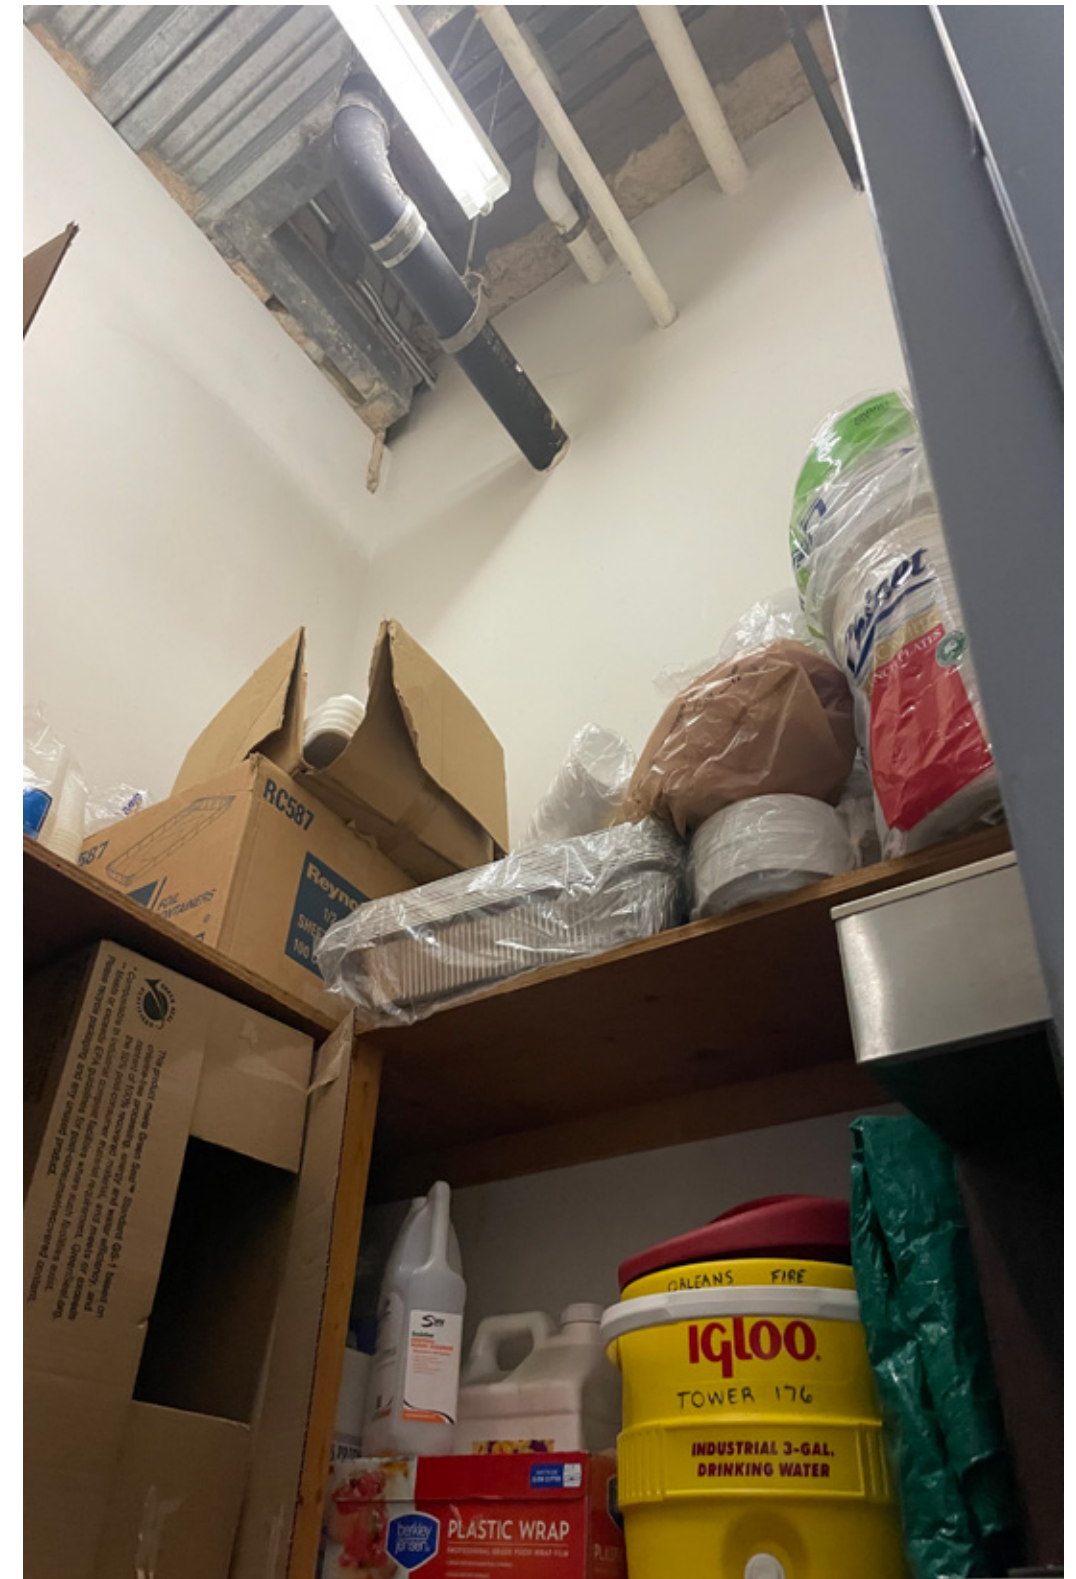
Town	Chatham	Brewster	Wellfleet	Harwich	Dennis	Orleans
Population - 2019	5,982	9,775	3,481	12,142	13,871	5,788
Est. Summer Population	35,000	20,000	16,000	63,000	63,000	20,000
Current Fire Station • Area	21,184 SF	22,500 SF	18,662 SF	Station #2 9,500 SF	Station #2 21,922 SF	11,500 SF
• Cost	\$10.6 million	\$13.5 million	\$5.5 million	\$6.75 million	Estimate \$14 million	
• Built	2016	2018	2009	2018	Projected 2022	1987
Total # of Calls 2020	2,785	2,644	1,152	4,351	5,030	2,364
Personnel/Station	32 Personnel 1 Station	31 Personnel 1 Station	18 Personnel 1 Station	31 Personnel 2 Stations	55 Personnel 2 Stations	34 Personnel 1 Station
Size Acres(est)	1.75	2.5	1.35	1.0	3.0	1.5

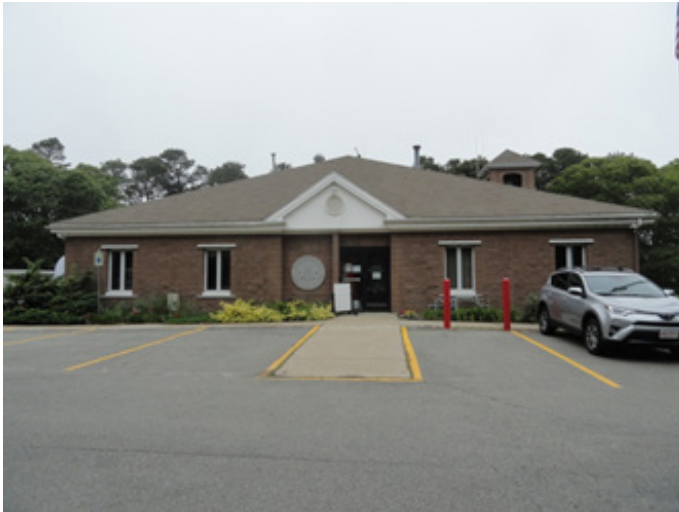
Photo #1 Building South Elevation
Main Entrance at the 1st Floor

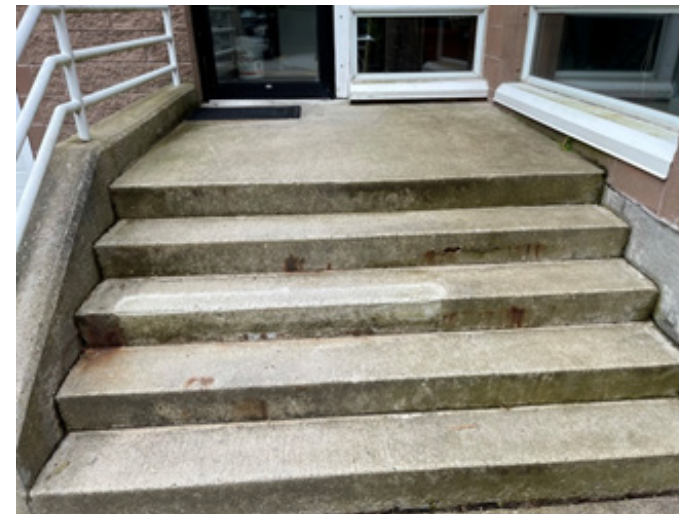
Photo #4 Building West Elevation
Concrete steps with minor cracks and surface
rusting observed

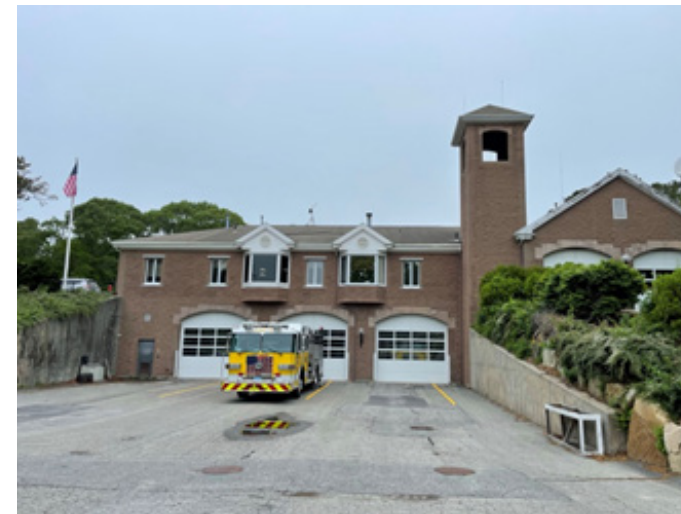
Photo #7 Building East Elevation
Hose Tower and the Main Apparatus Garage
Doors at the basement level

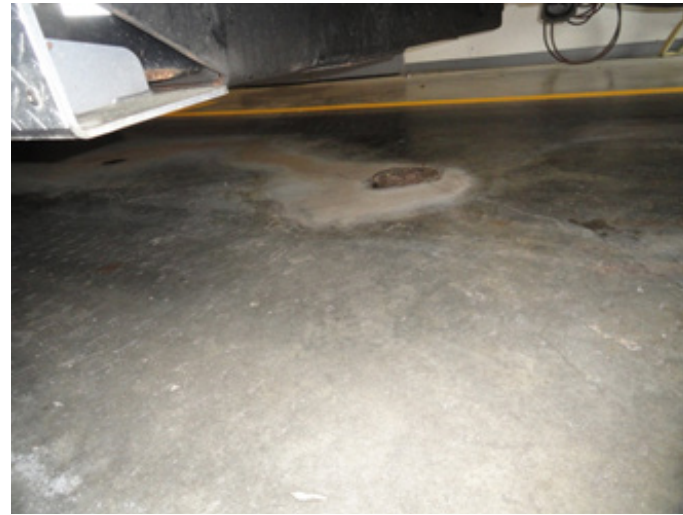
Photo #10 Basement Apparatus Room slab
Shrinkage cracks at the front north bay

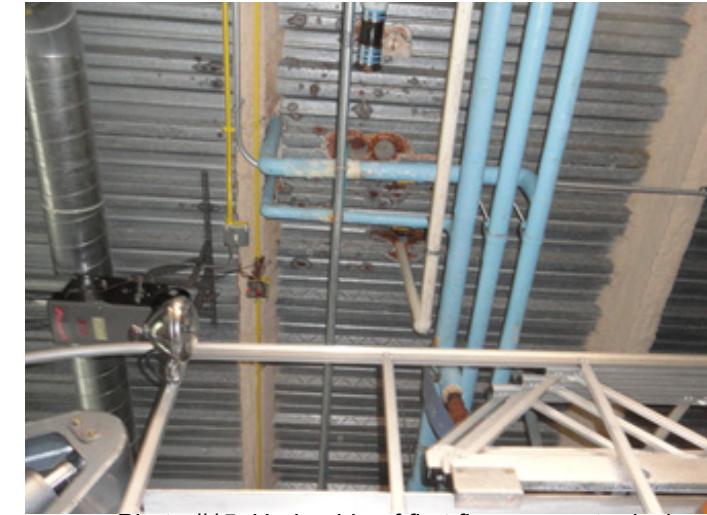
Photo #15 Underside of first floor concrete deck
above the apparatus front north bay
Surface rust is observed at the steel deck and
floor penetrations

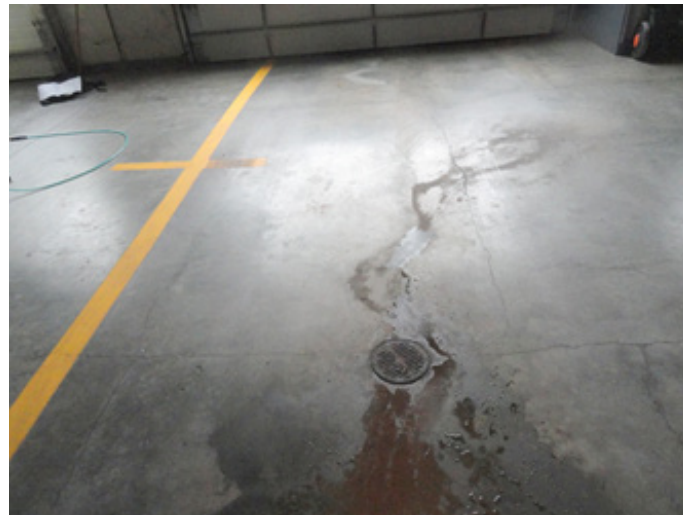
Photo #11 Basement Apparatus Room slab
Shrinkage cracks at the front middle bay

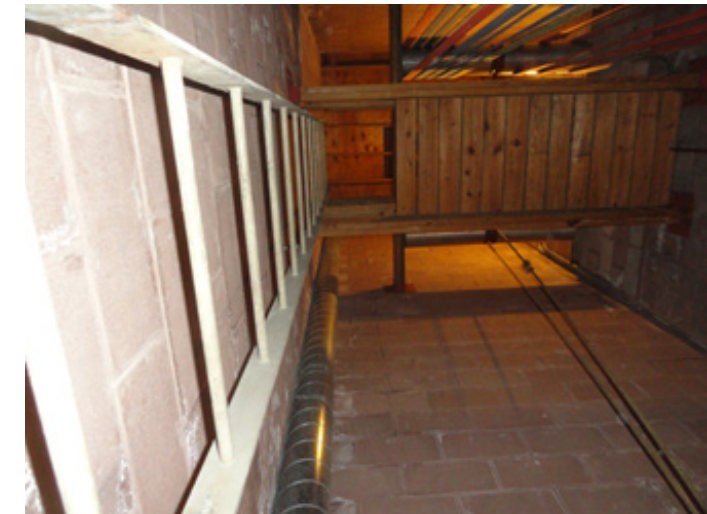
Photo #16 Hose Tower - interior masonry

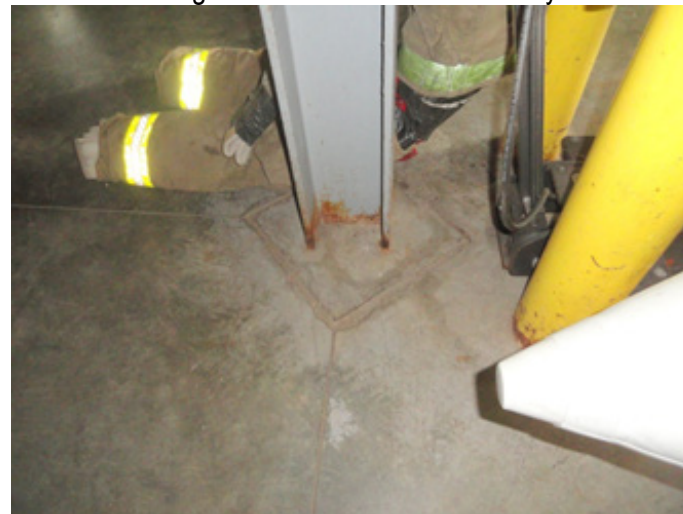
Photo #14 Basement Apparatus Room Surface rust is
observed at the bottom of the steel column

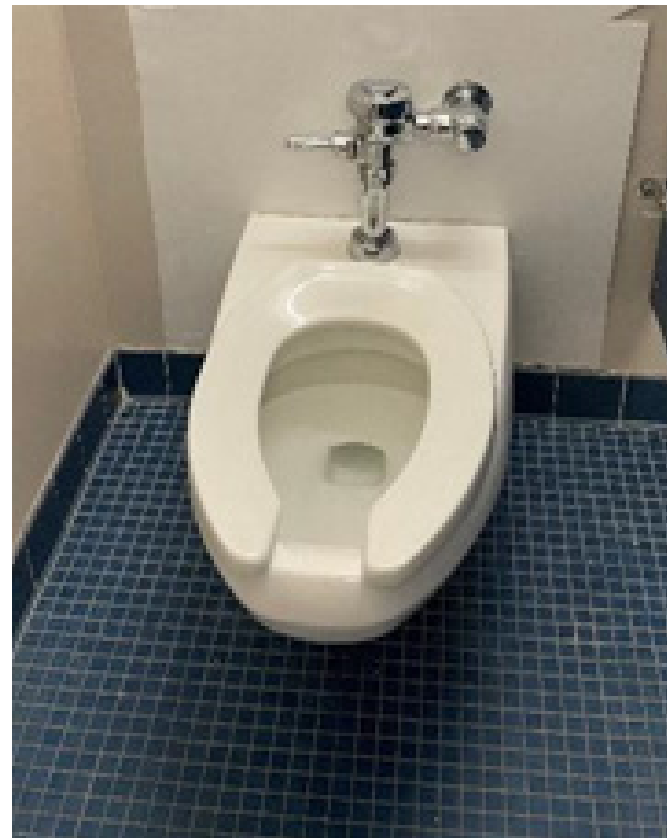
Existing Water Closet

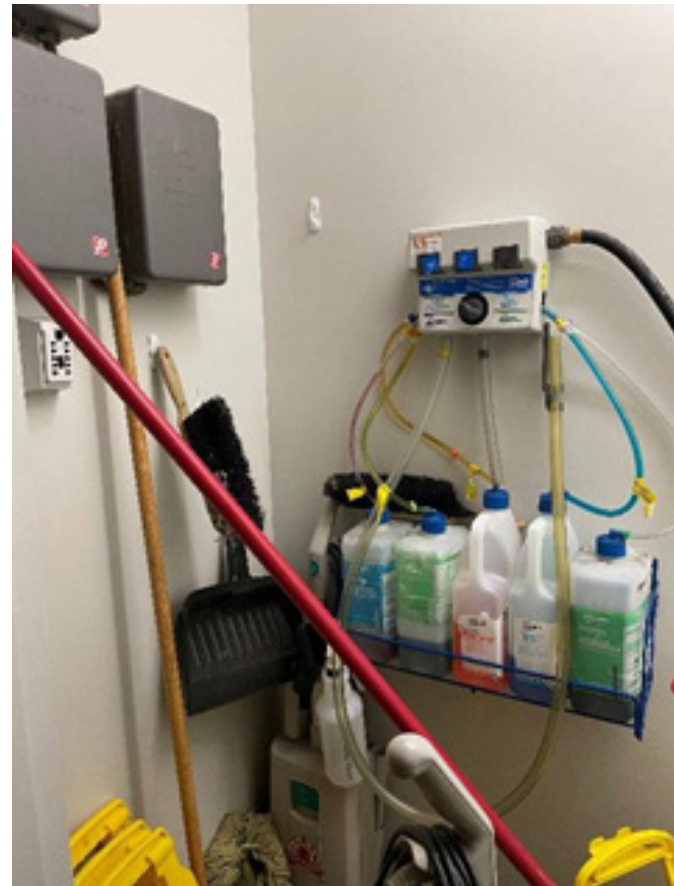
Chemical Dispensing Unit

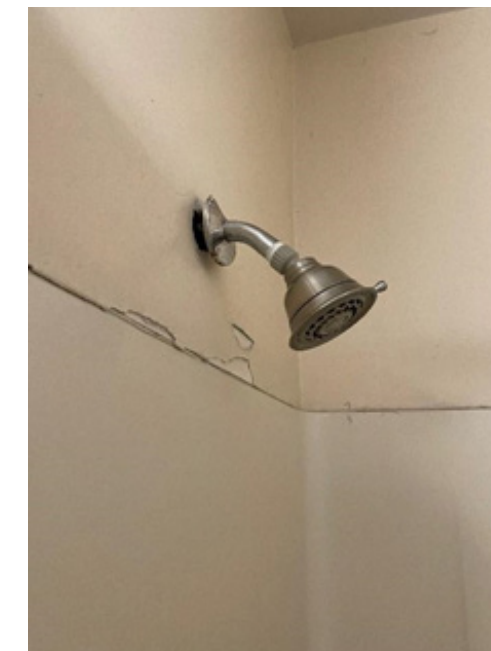
Existing Shower Head

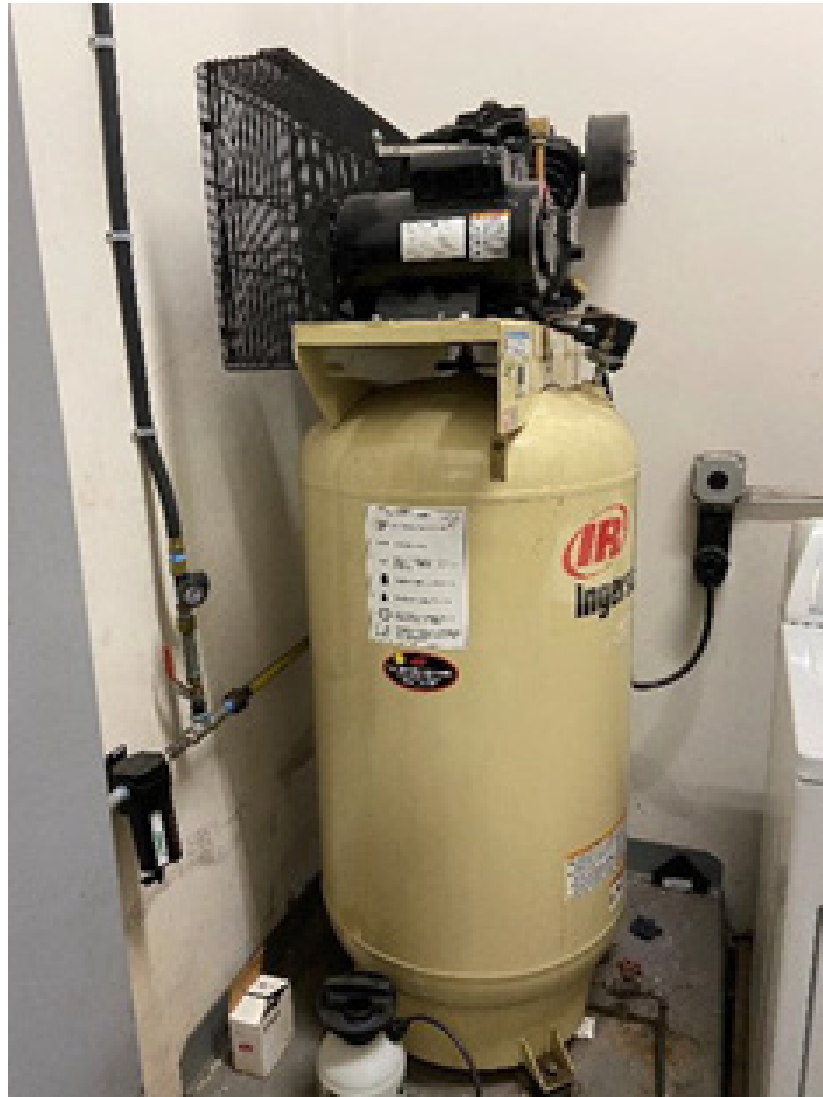
6. Air Compressor: An air compressor is provided for compressed air throughout the facility. The air compressor appears to be in good condition but there are no acoustical barriers between the compressor and washer/dryer room

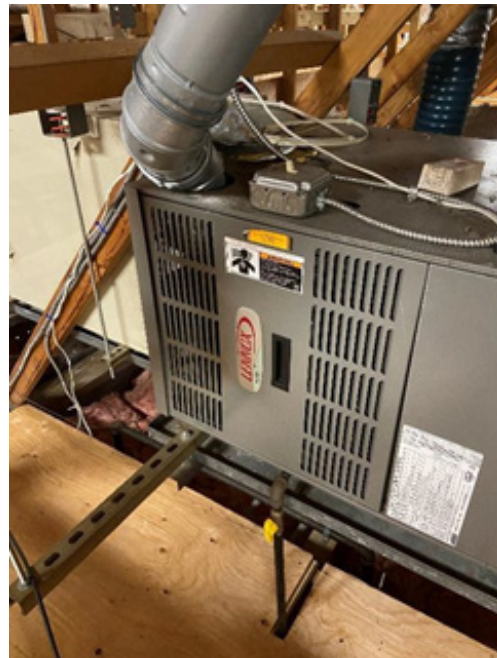
Furnace Unit in Attic Space

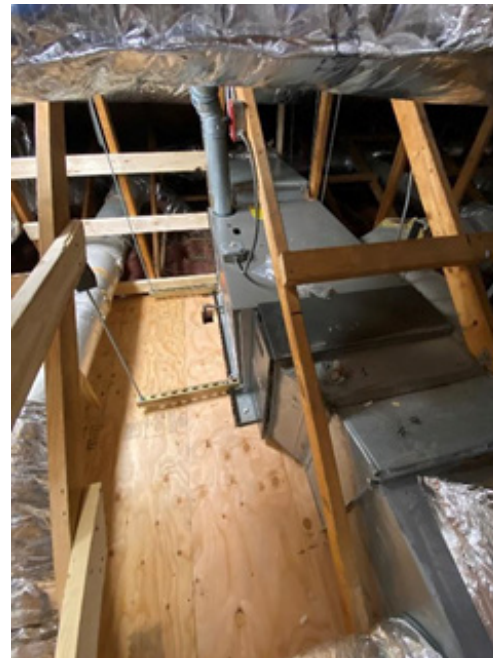
Furnace Unit in Attic Space

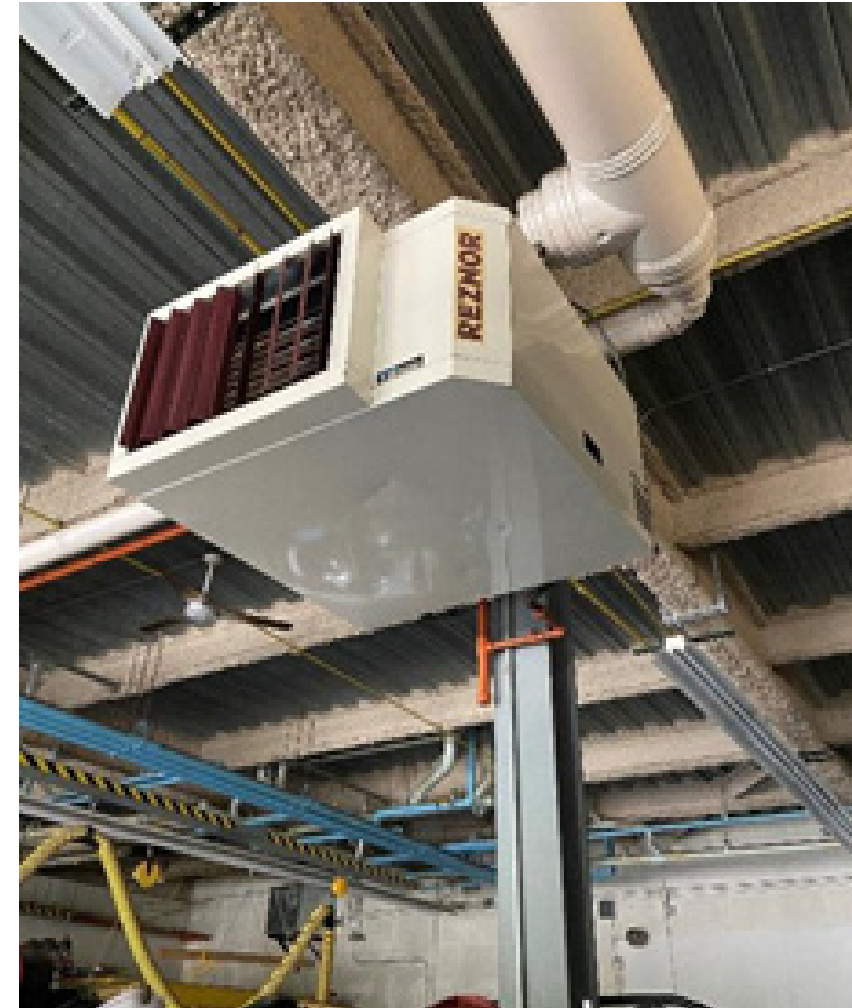
Gas Fired Unit Furnace

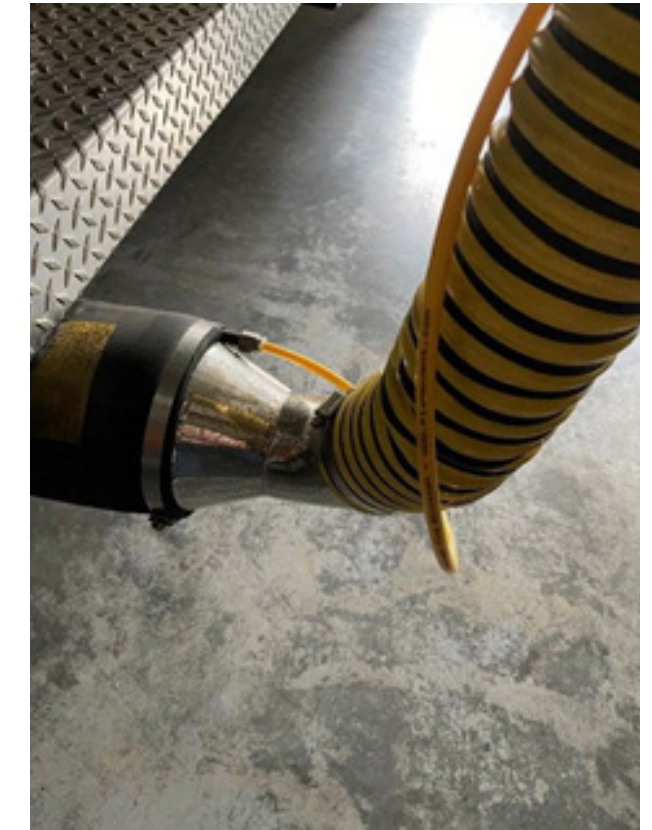
Vehicle Exhaust Pneumatic Grabber

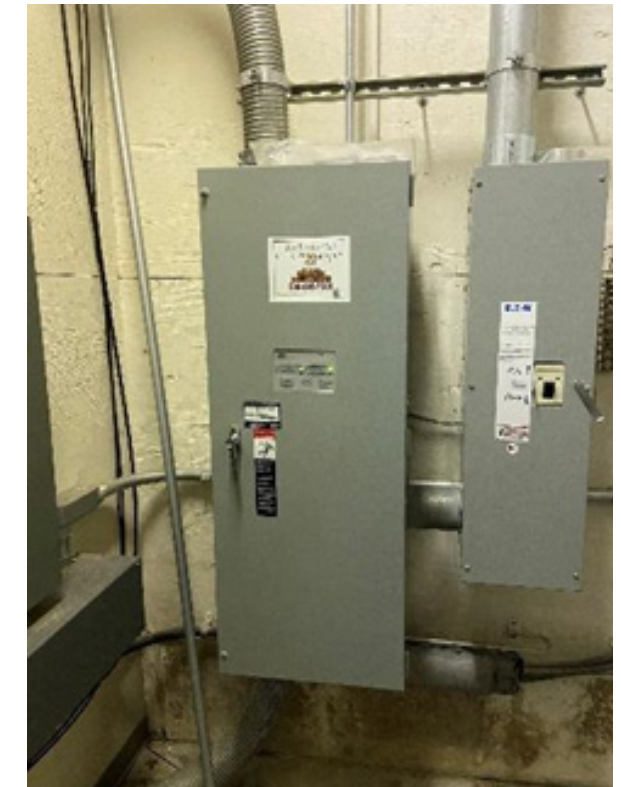
Automatic Transfer Switch

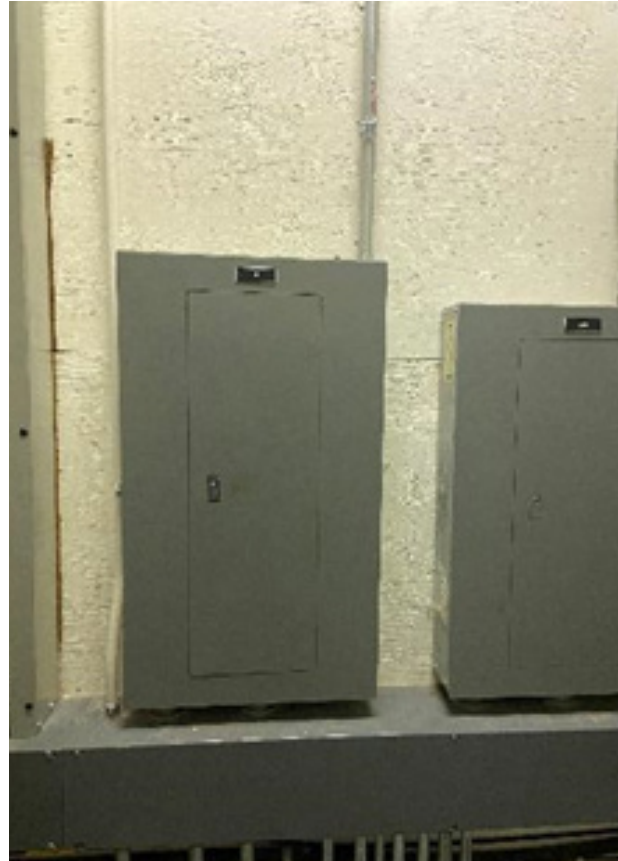
Older Electrical Panels

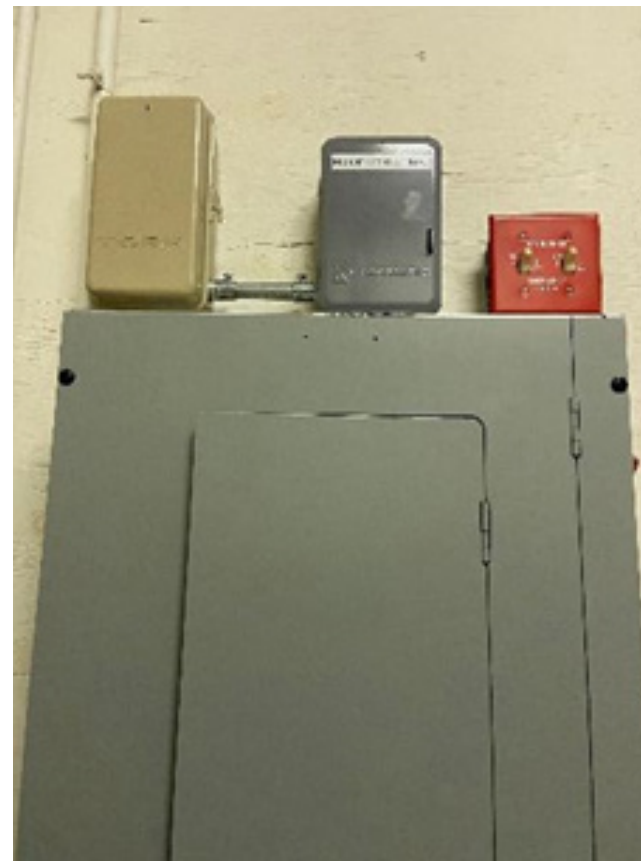
Newer Electrical Panel

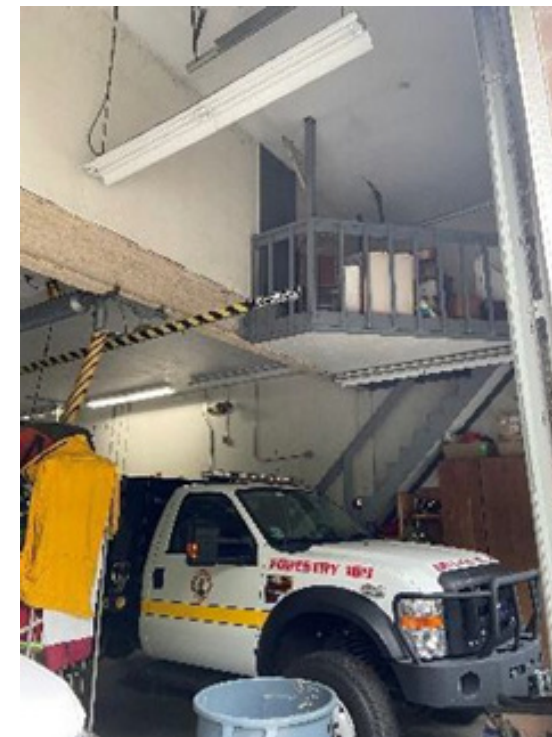
Pendant Industrial Fixture

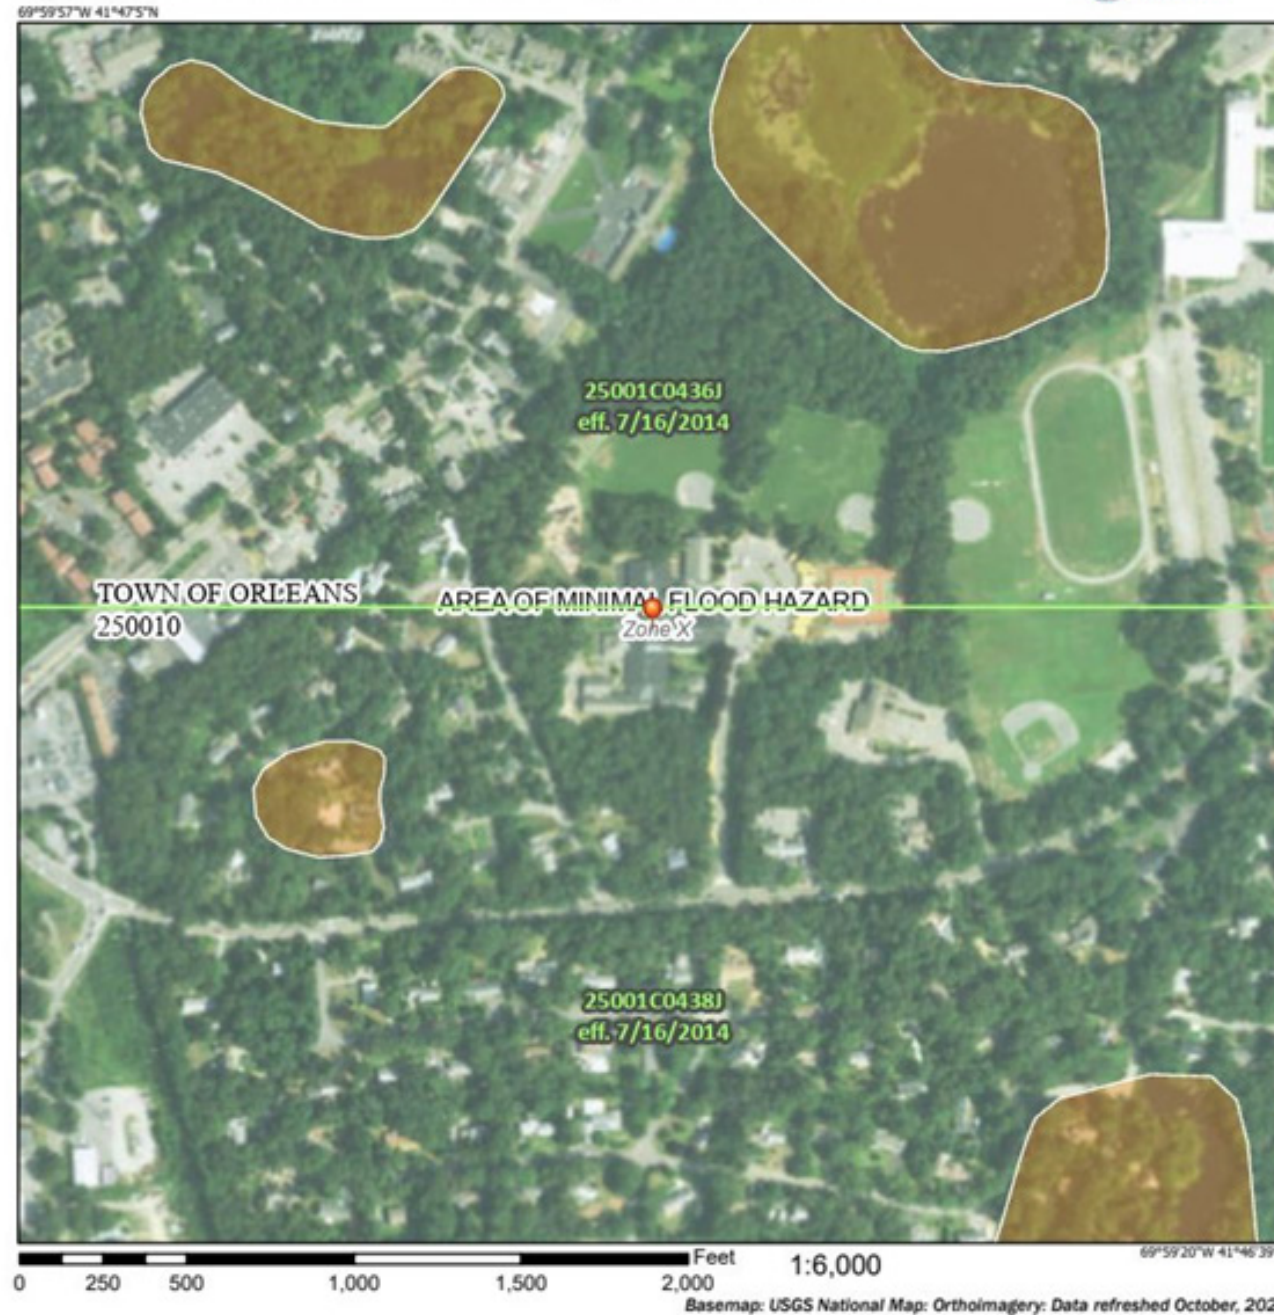
National Flood Hazard Layer FIRMette

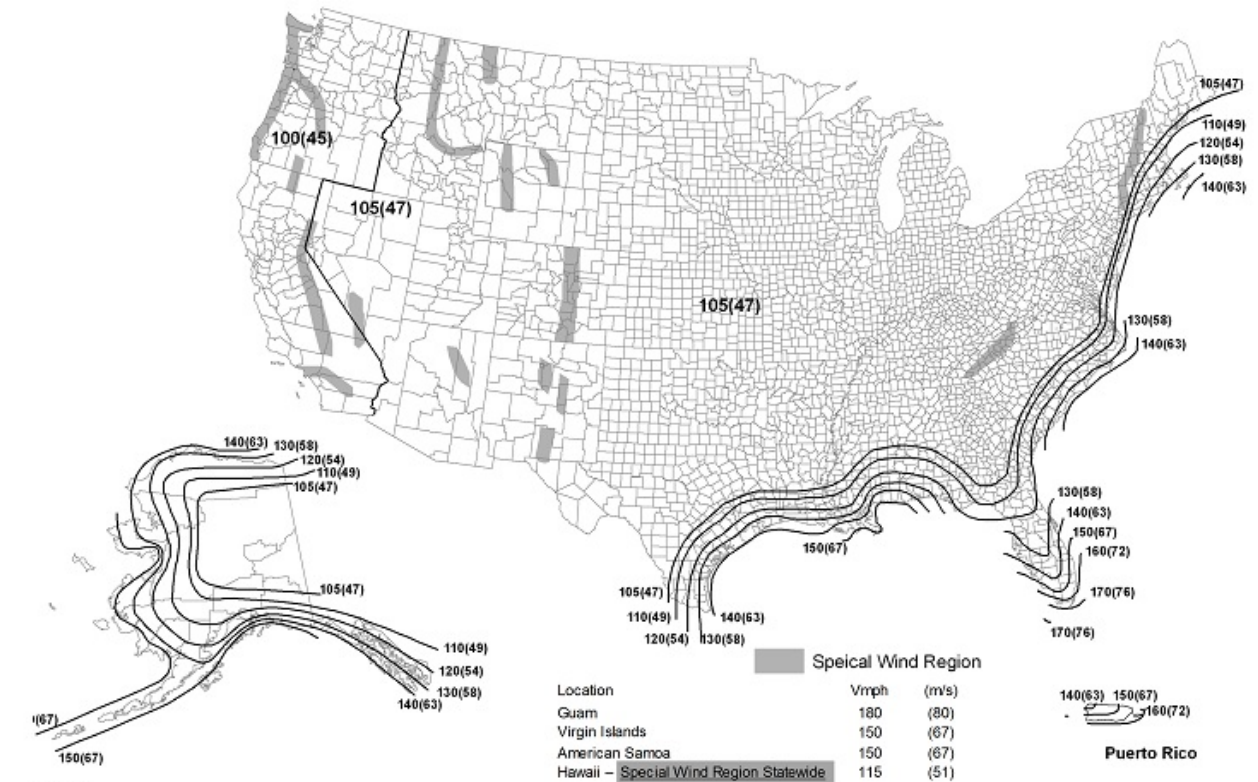
Notes:
 1. Values are nominal design 3-second gust wind speeds in miles per hour (m/s) at 33 ft (10m) above ground for Exposure C category.
 2. Linear interpolation between contours is permitted.
 3. Islands and coastal areas outside the last contour shall use the last wind speed contour of the coastal area.
 4. Mountainous terrain, gorges, ocean promontories, and special wind regions shall be examined for unusual wind conditions.
 5. Wind speeds correspond to approximately a 15% probability of exceedance in 50 years (Annual Exceedance Probability = 0.00333, MRI = 300 Years).
