TOWN OF ORLEANS

FIRE STATION FEASIBILITY STUDY

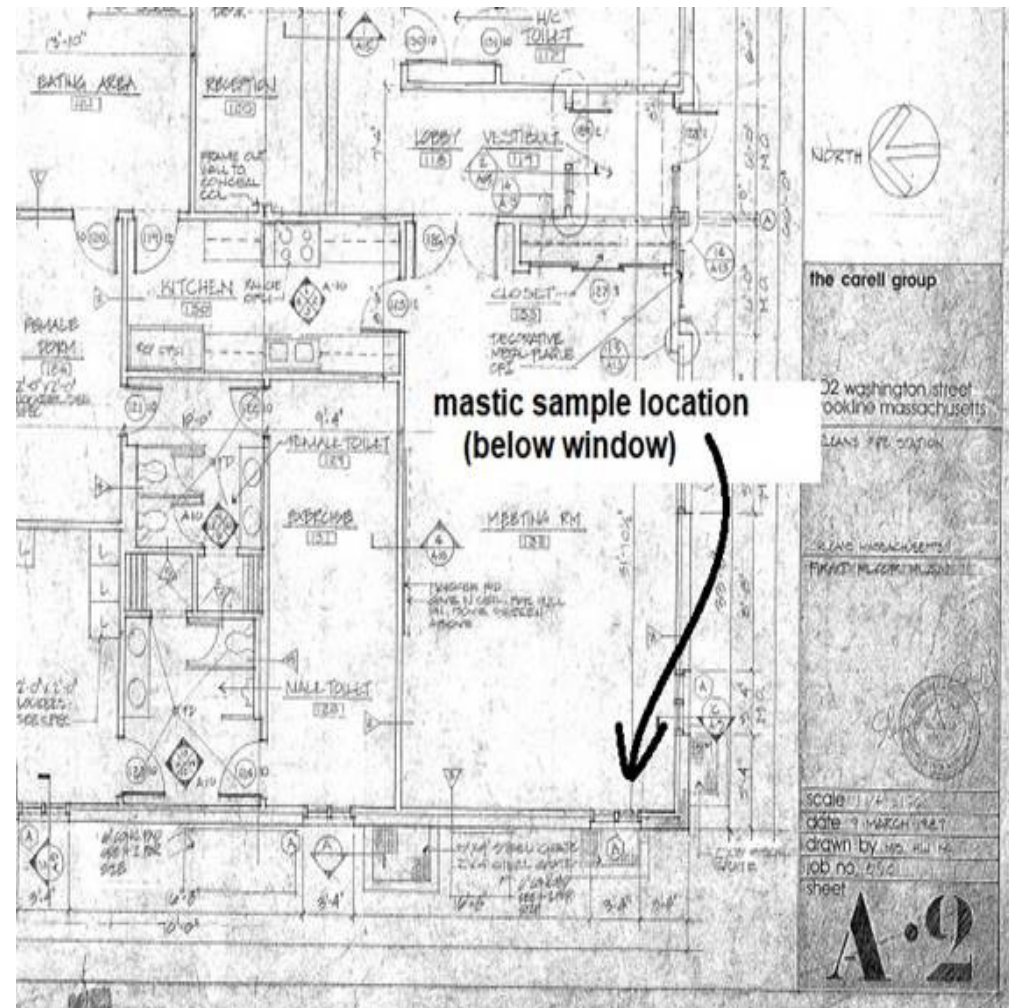
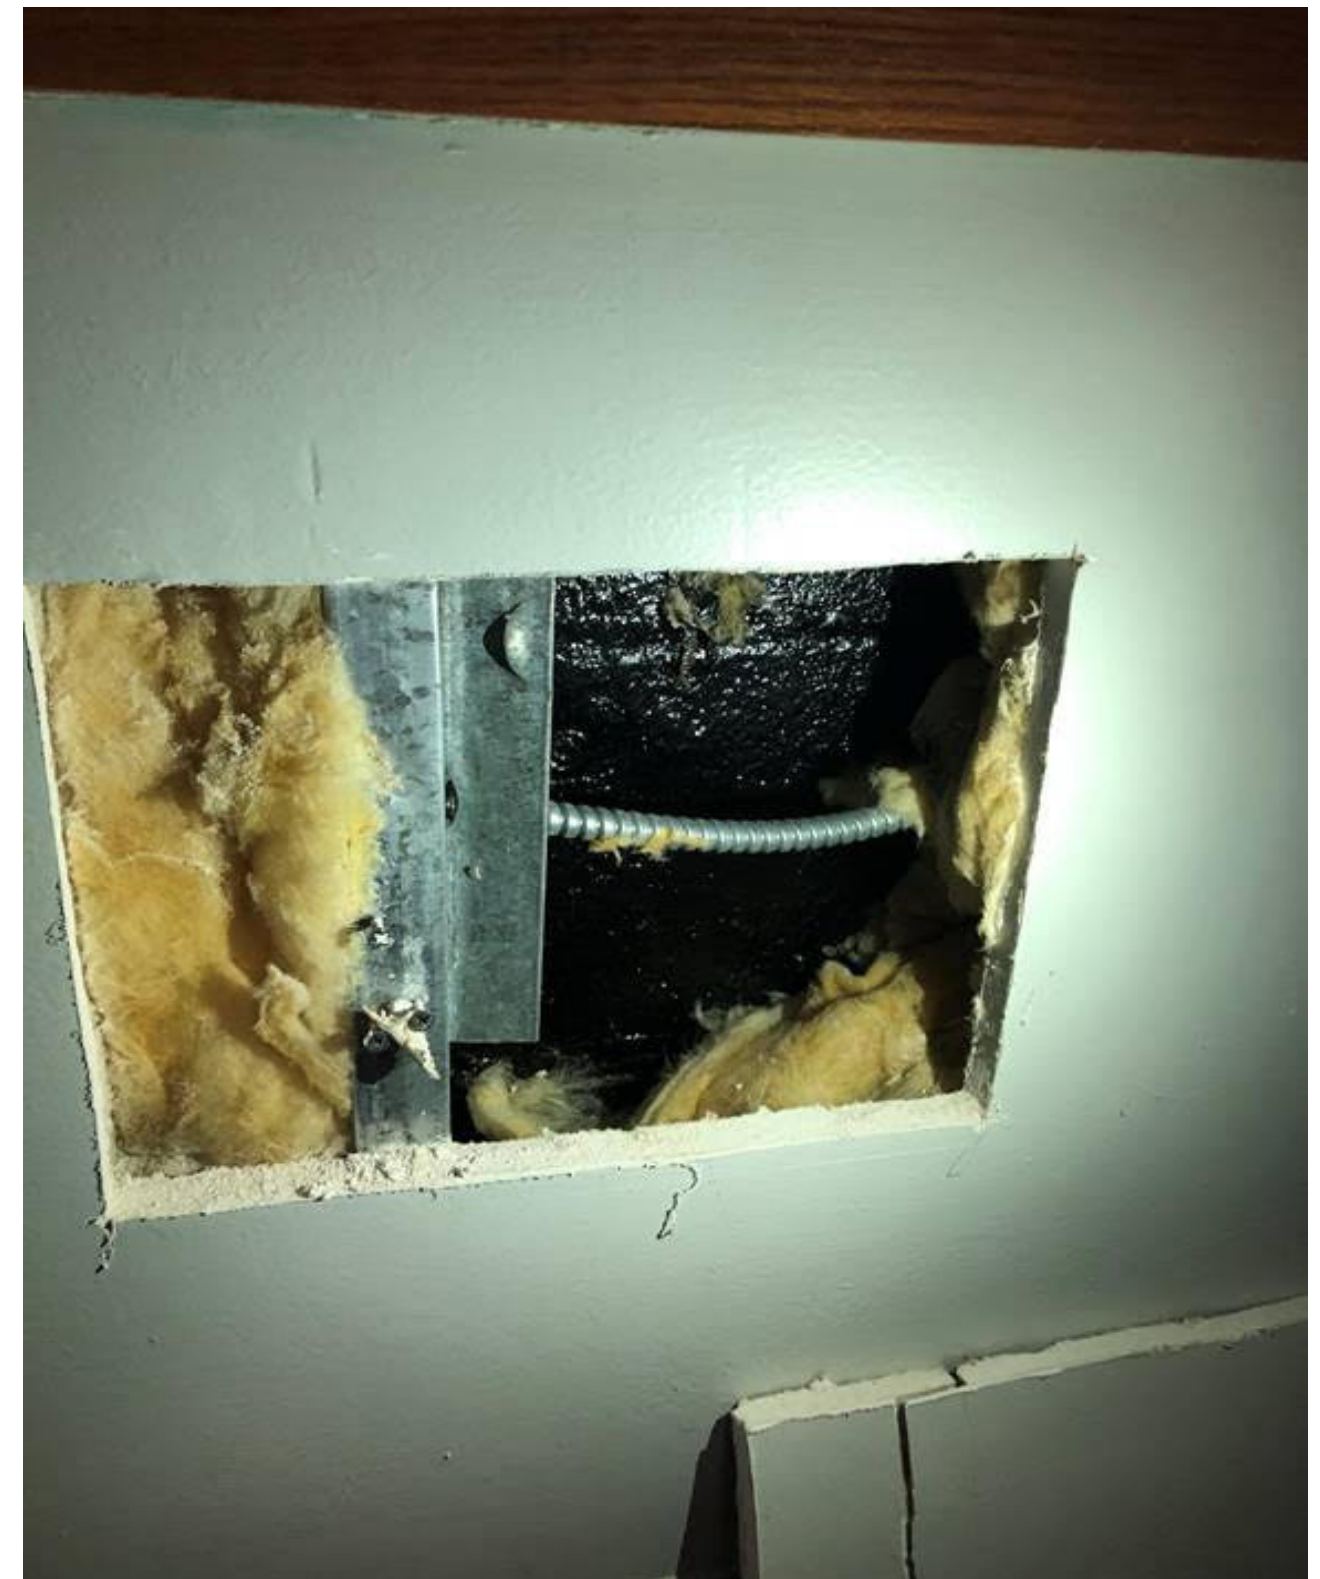
FIREHOUSE RENOVATE OR REPLACE?

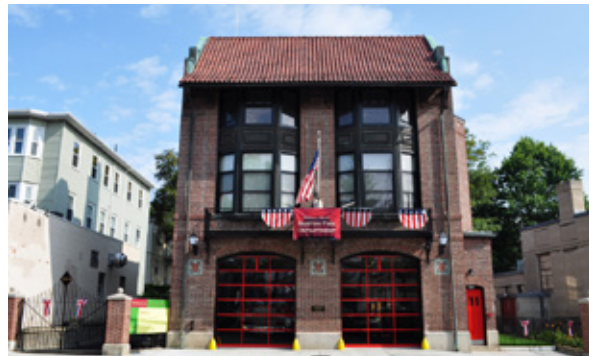
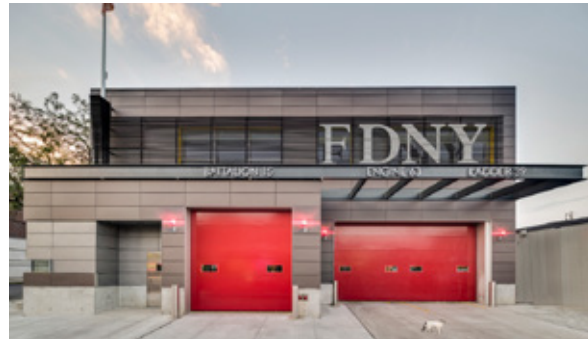
color or even structural density requires a lot of effort on the part of the architect. Moreover, mortar needs to be replicated in a way that matches existing conditions, but also structurally performs in equal capacity to existing mortars. However, historic preservation provides the opportunity to save beloved building elements like an old cornice line, a limestone carving or some other element that shows the public that we believe in preserving the department's institutional heritage.

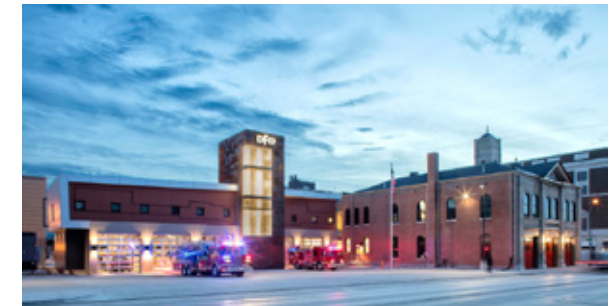
TEMPORARY FACILITY STUDY
